**AGENDA - TROY PLANNING COMMISSION MEETING
WEDNESDAY, JUNE 10, 2020, 3:30 P.M.**

TO:	Troy Planning Commission
FROM:	Planning Staff
DATE:	May 13, 2020
SUBJECT:	Historic District Review: 126 South Cherry Street
OWNER:	First United Methodist Church
APPLICANT:	Linda Bosick, Trustee Chair

STRUCTURAL EVALUATION 126 SOUTH CHERRY STREET TROY, OHIO 45373

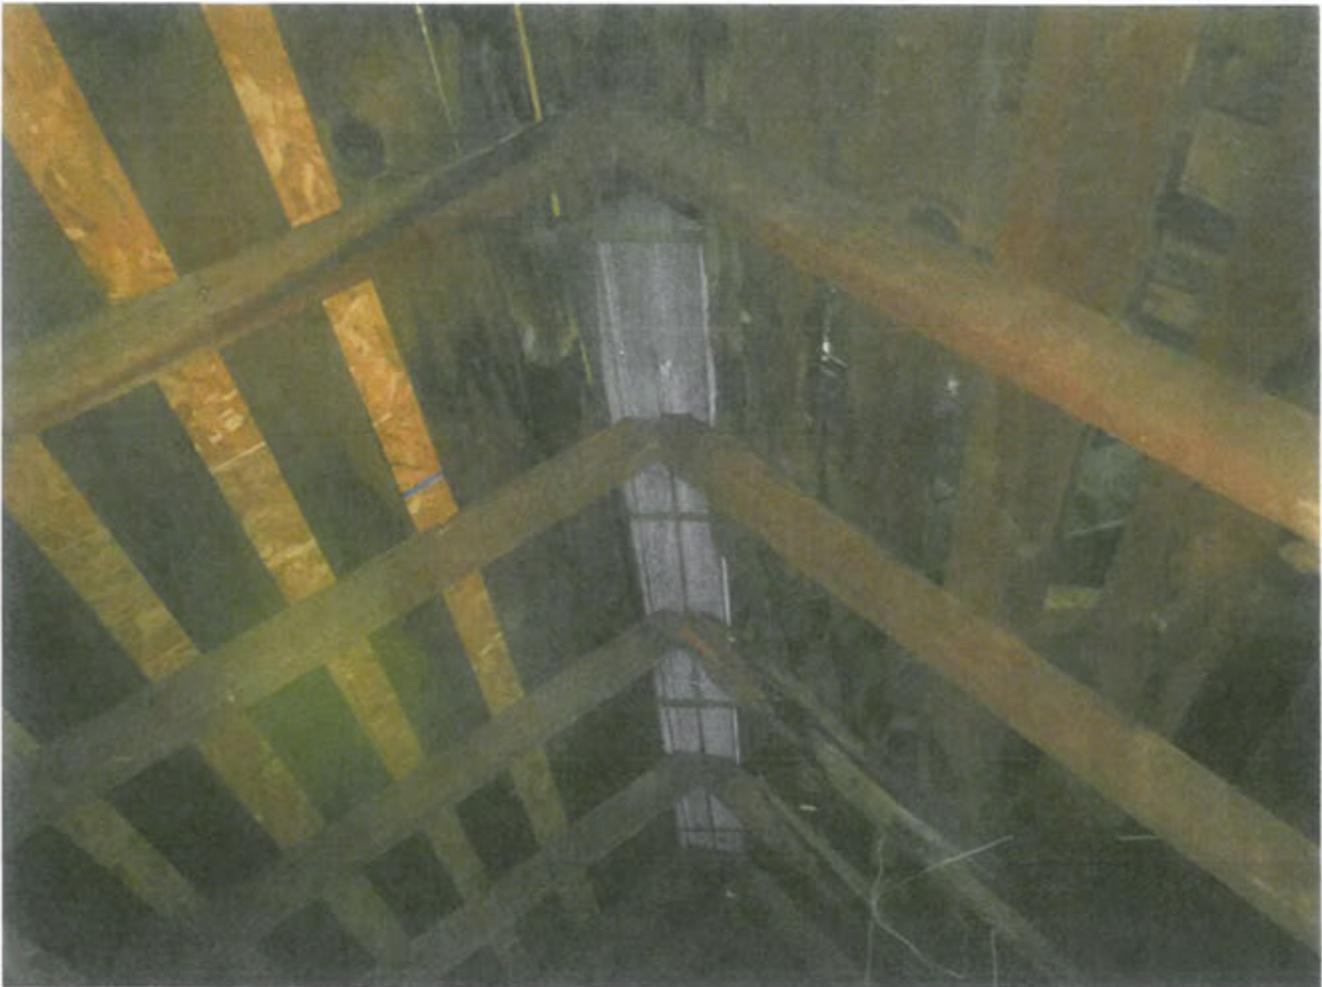
The roof construction consists of traditional asphalt shingles on OSB sheathing atop the original plank board sheathing supported by clear-span timber roof rafters. The roof rafters bear their weight on the front and rear walls at the rear of the house and on the side walls at the front. The interior walls of the second floor do support the ceiling joists. With the age of this house and repeated heavy loads due to snow loads the roof framing is separated in numerous locations along the ridge and should be secured together using metal clips and wood screws. The rafter framing around the chimney has deteriorated most likely due to water infiltration and should be rebuilt.

Picture of the newer OSB sheathing on the original plank board sheathing.

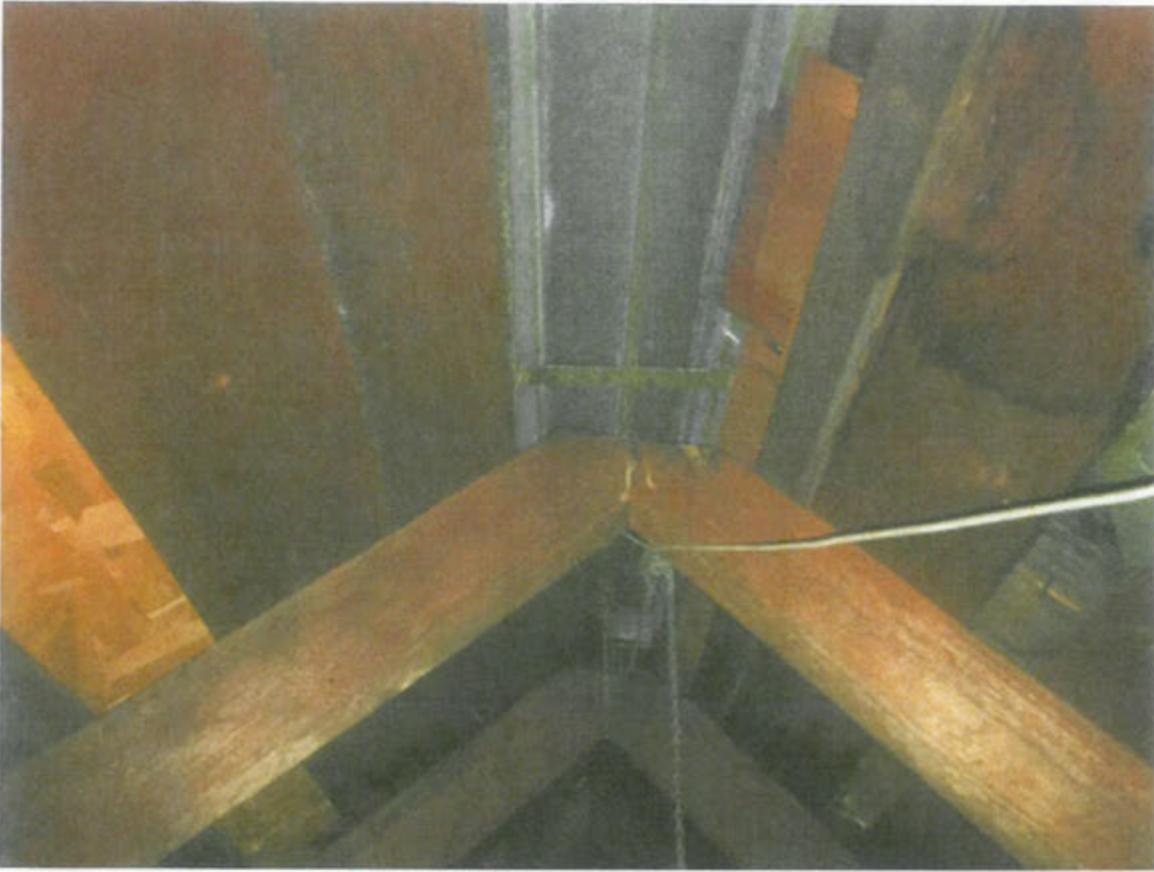
Picture of the cut and separating rafters at the ridge.

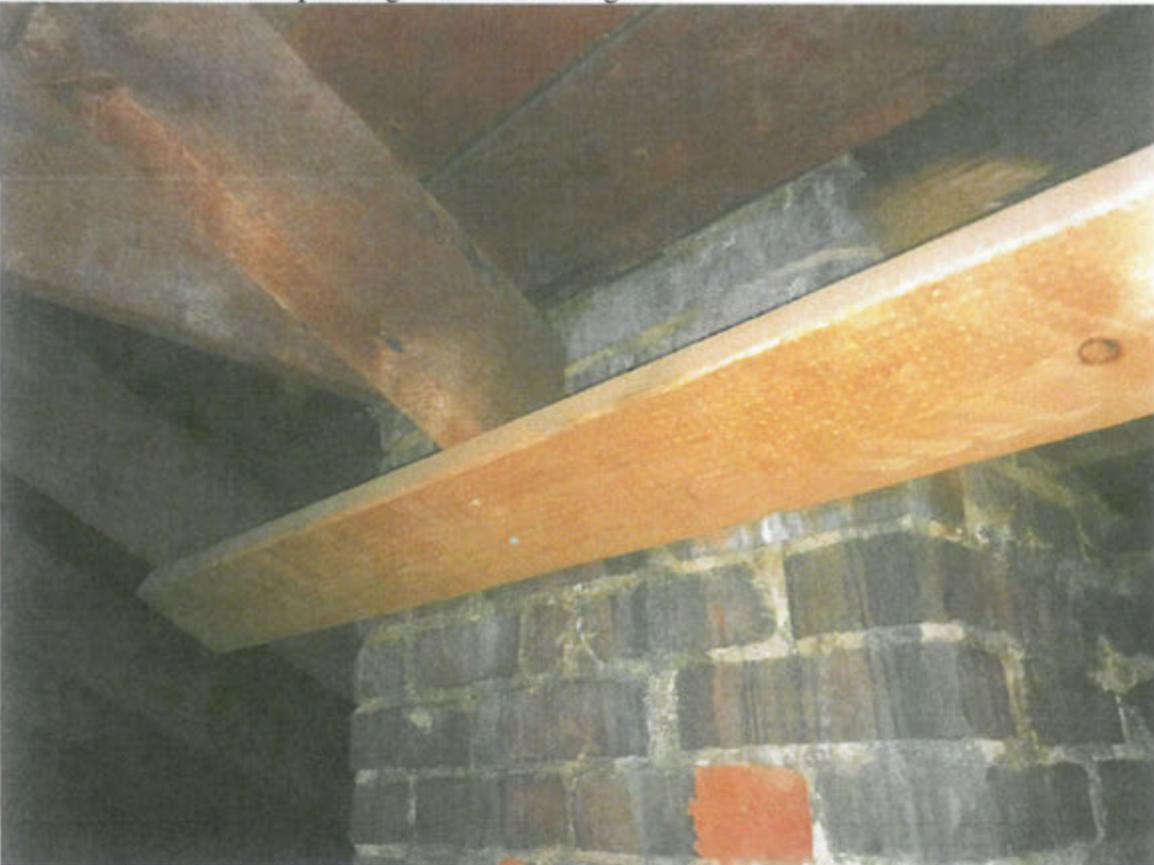
Picture of an attempted support and repair of the rafter framing at the chimney.

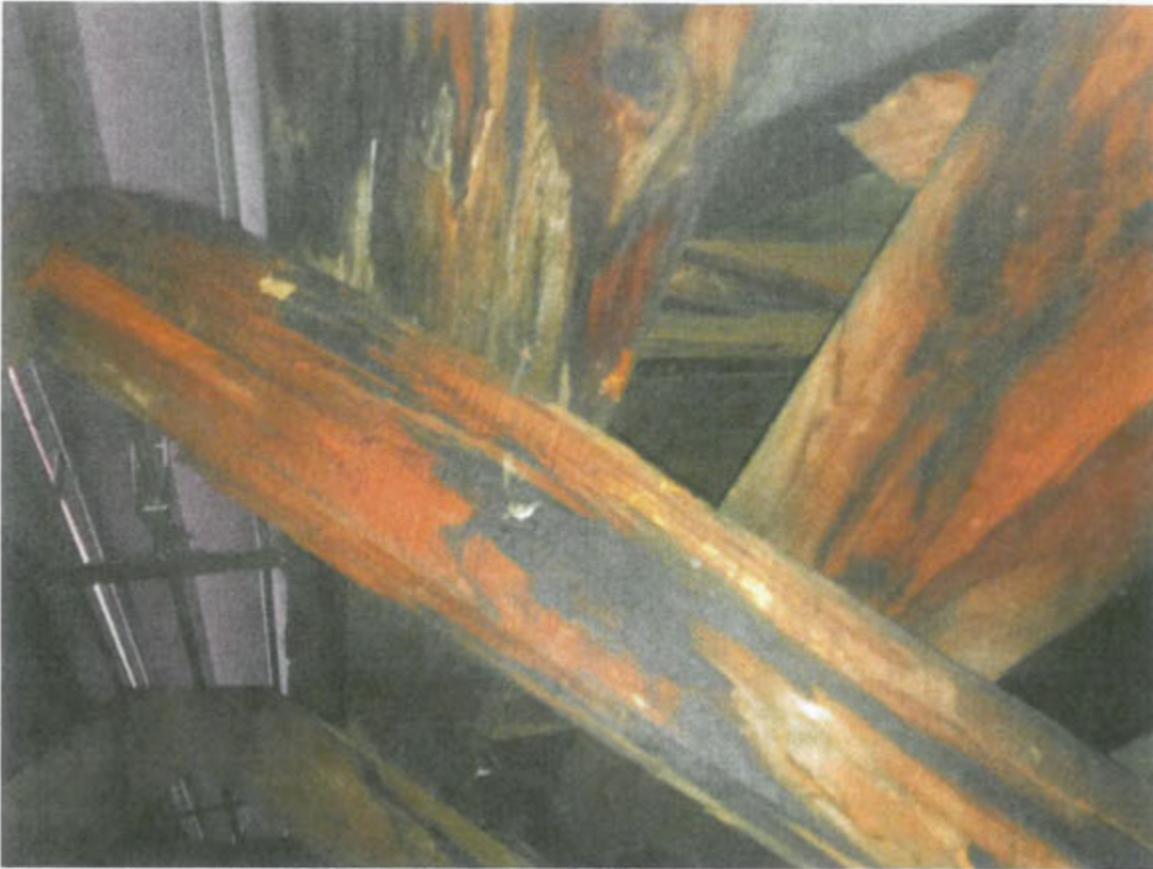
Picture of water stains on the plank boards and rafters.

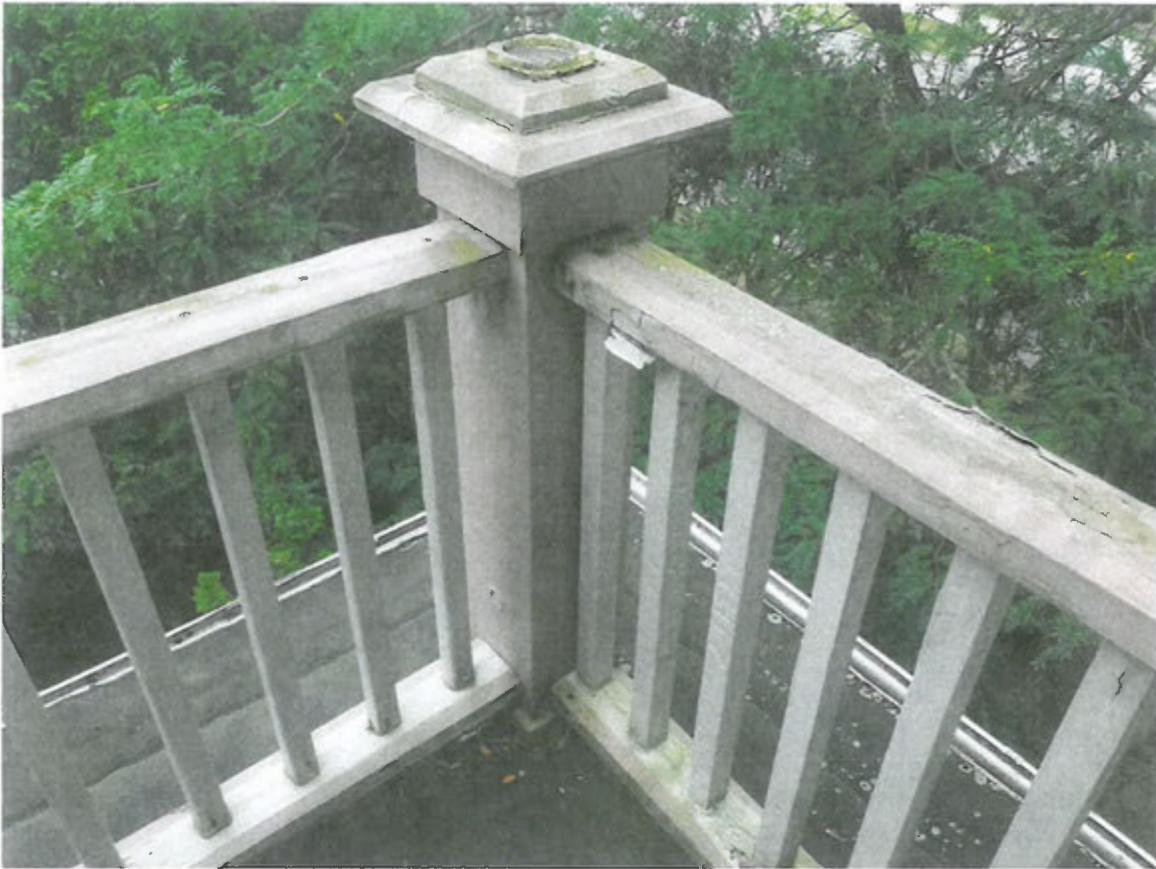
The roof above the front porch is accessible through a second floor door and has a post and railing around the perimeter. The horizontal supports of the holding the vertical pickets have decayed and the railing should be rebuilt and any members replaced as necessary.

Picture of the railing above the front porch on the second level.

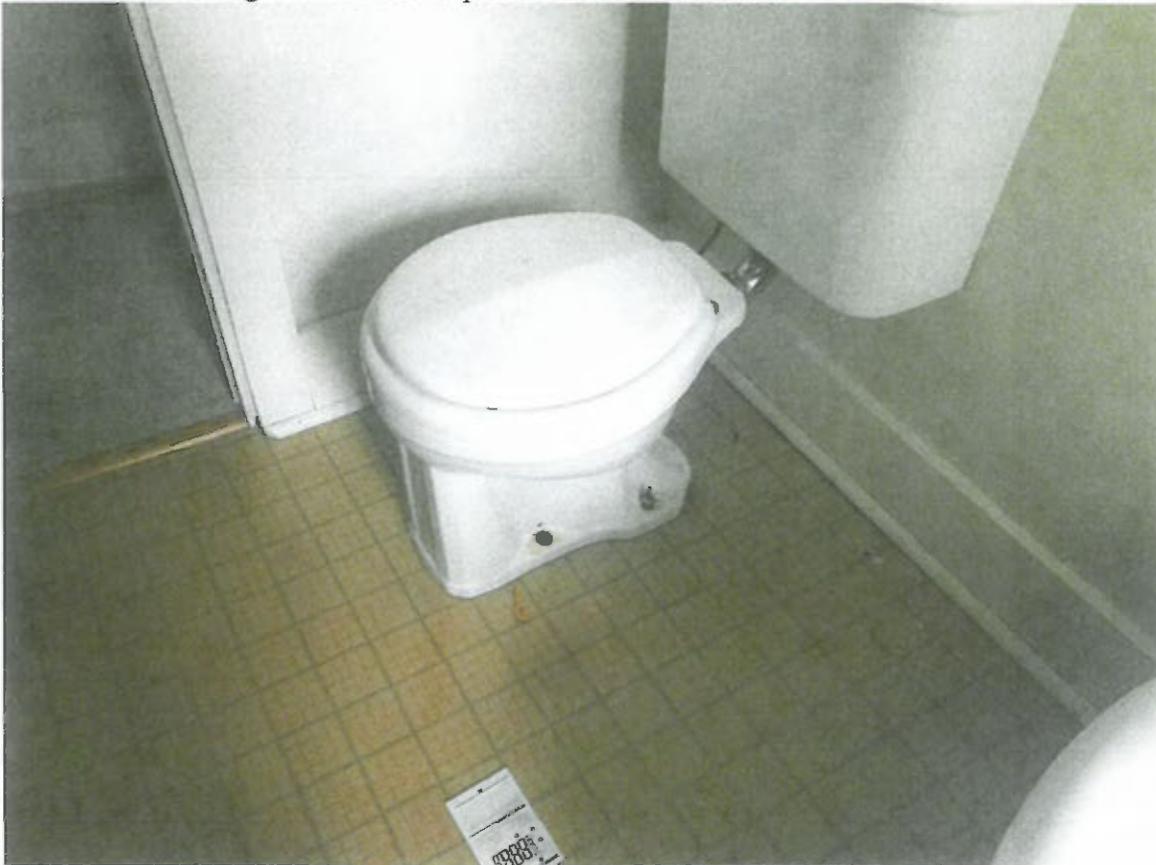
The second floor framing is not visible for direct inspection but most areas showed no areas of softness or weak joists except for the flooring around the toilet, a common problem due to leaking water. The floor should be pulled up to check for compromised subfloor and the floor joists fully inspected.

Picture of the second floor toilet to further inspect after removing the flooring.

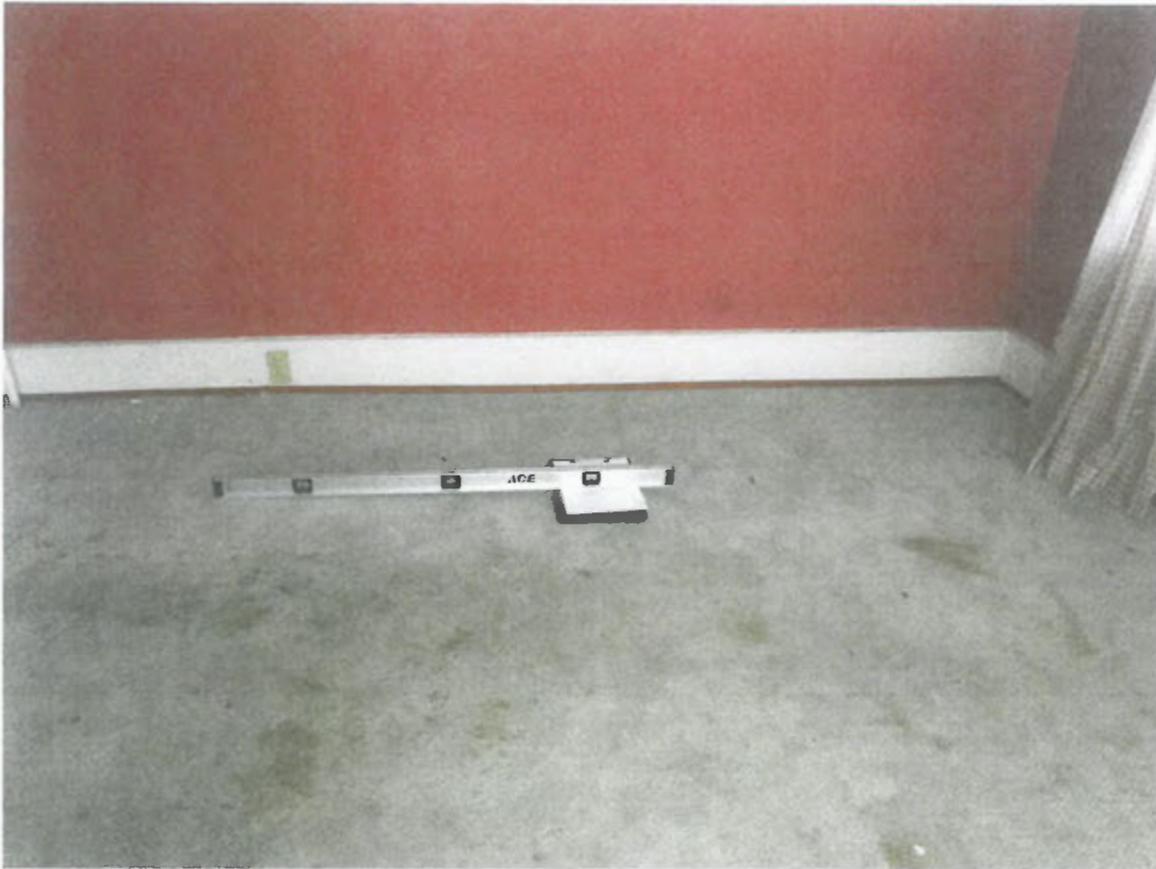
On the north side of the house the first floor framing slopes significantly downward toward the outside foundation wall. This area is a crawlspace and not visible for direct inspection. The shallower footings have settled and the side wall and front and rear foundation walls will need to have steel piers installed below the footings to stabilize it and raise it back to its original height.

Picture of the unlevel floor on the northeast side.

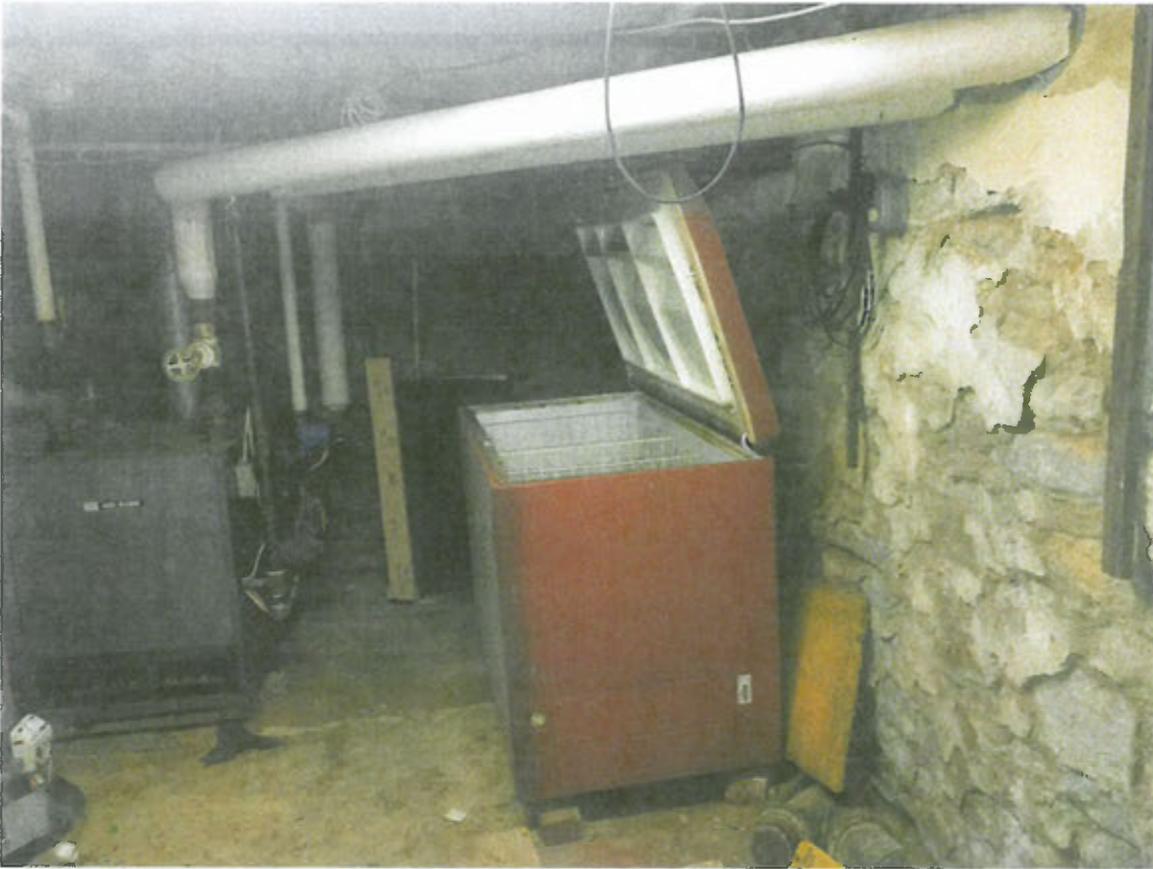
The original cellar below the house is a stone wall basement below the original rear portion of the house. The front area of the house is built above a shallow crawlspace with no direct access. The stones of the cellar walls should be thoroughly cleaned, any dirt pushing from the exterior between the stones removed, and new mortar tuck pointed between the stones to restore the bond between the stones and restore the structural integrity of the walls. The floor is partially concrete and dirt, the dirt half should be prepped and a new concrete slab poured to complete the floor with at least a 4" thick concrete slab.

Picture of the stone basement walls to clean and tuck point with new mortar.

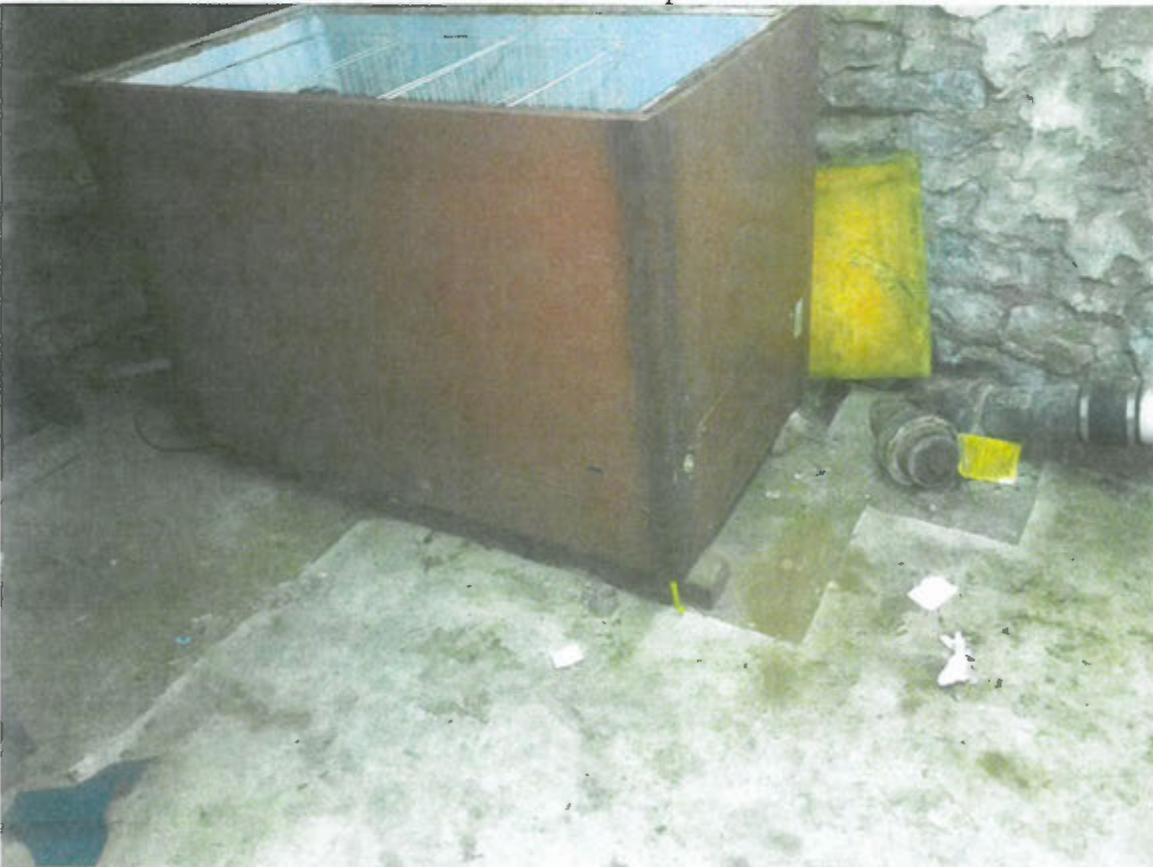
Picture of the concrete and dirt floors.

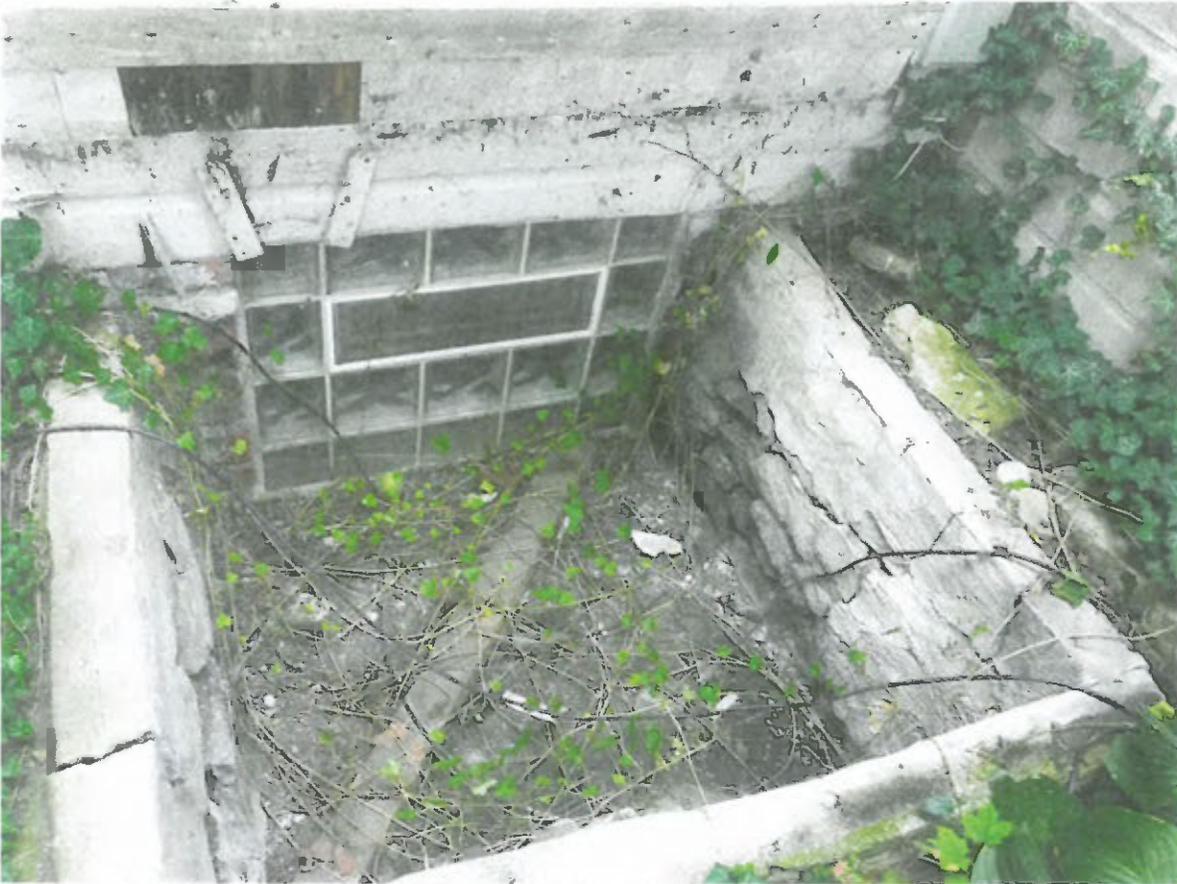
Picture of a deteriorated stone window well to be rebuilt.

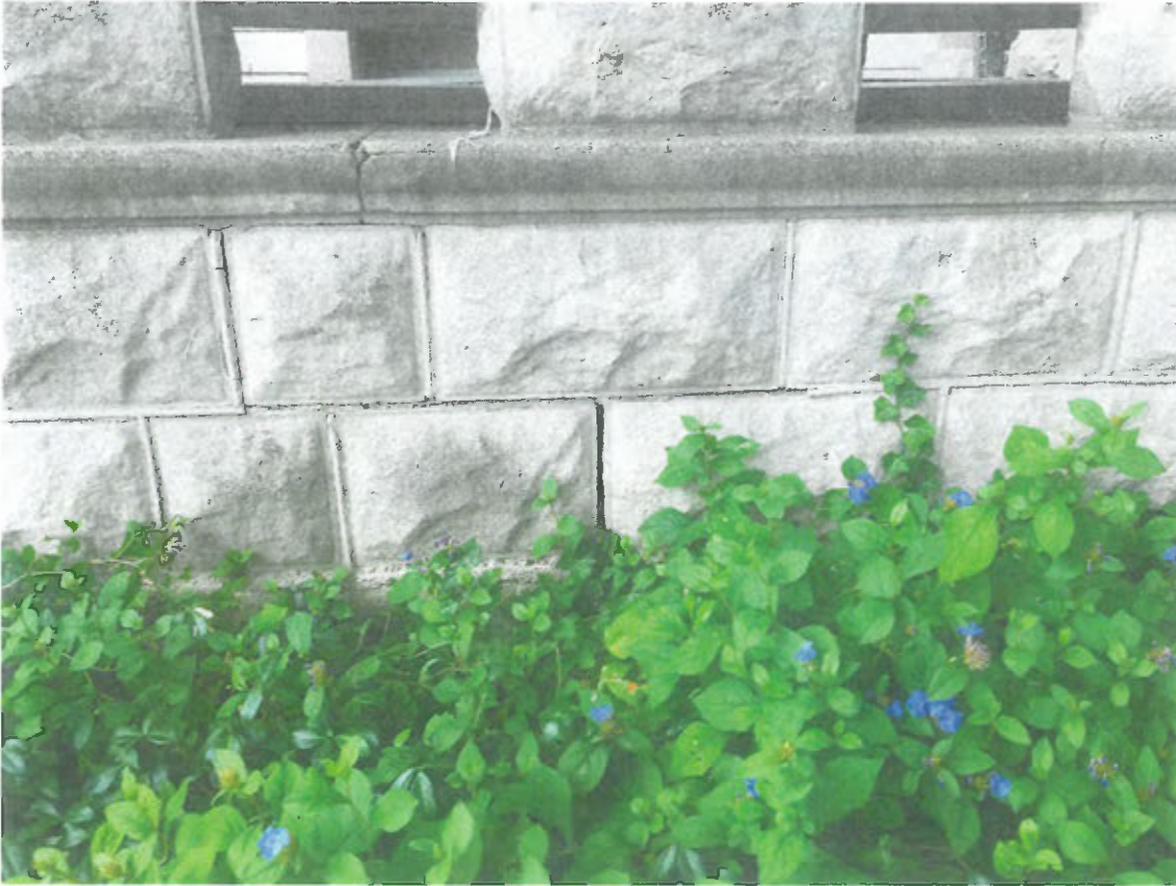
The stone blocks of the foundation wall of the front porch show signs of lateral movement such as gaps in the vertical mortar joints. Any gaps such as this should have the mortar cut out and new mortar tuck pointed in to restore the bond between the blocks.

Picture of the foundation wall blocks of the front porch.

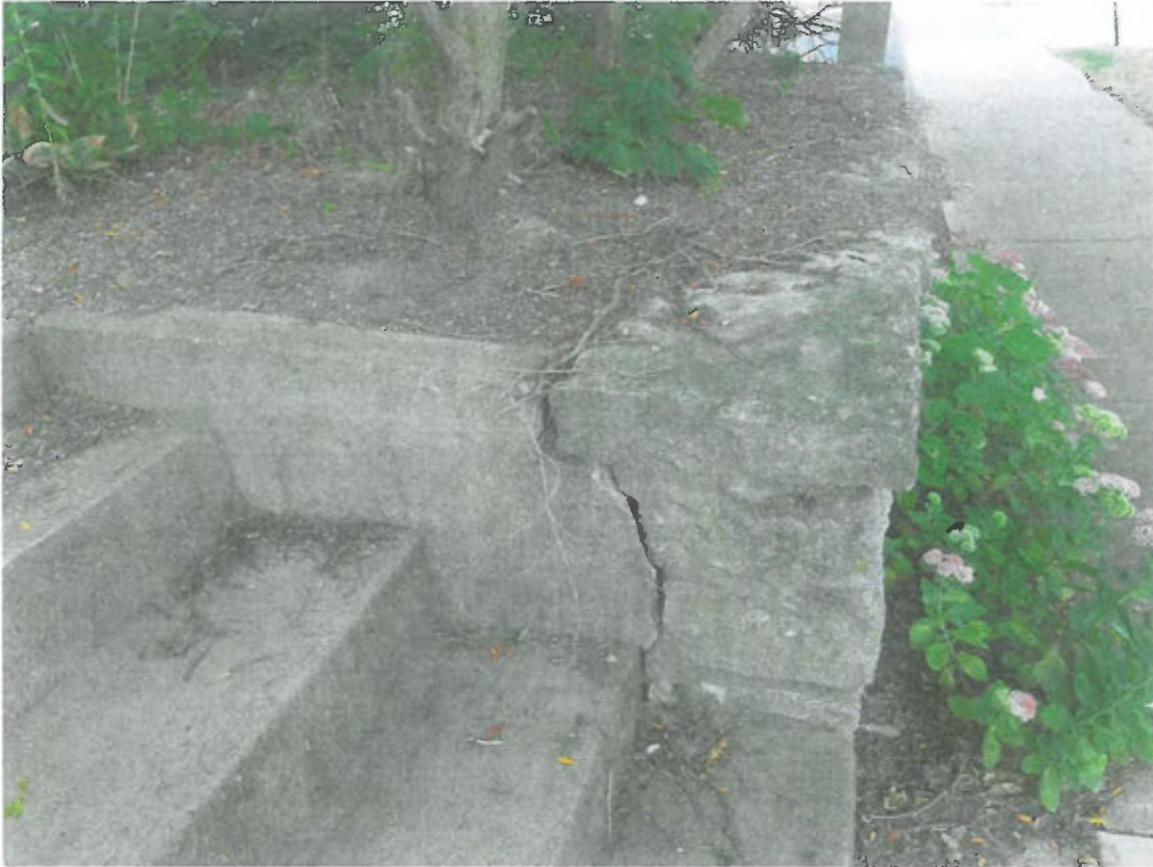
The stone retaining wall at the front of the property adjacent to the sidewalk has cracked and is leaning slightly. The wall should be rebuilt to correct any leaning and restore the strength between the stones with new mortar.

Picture of the cracked front retaining wall adjacent to the front steps.

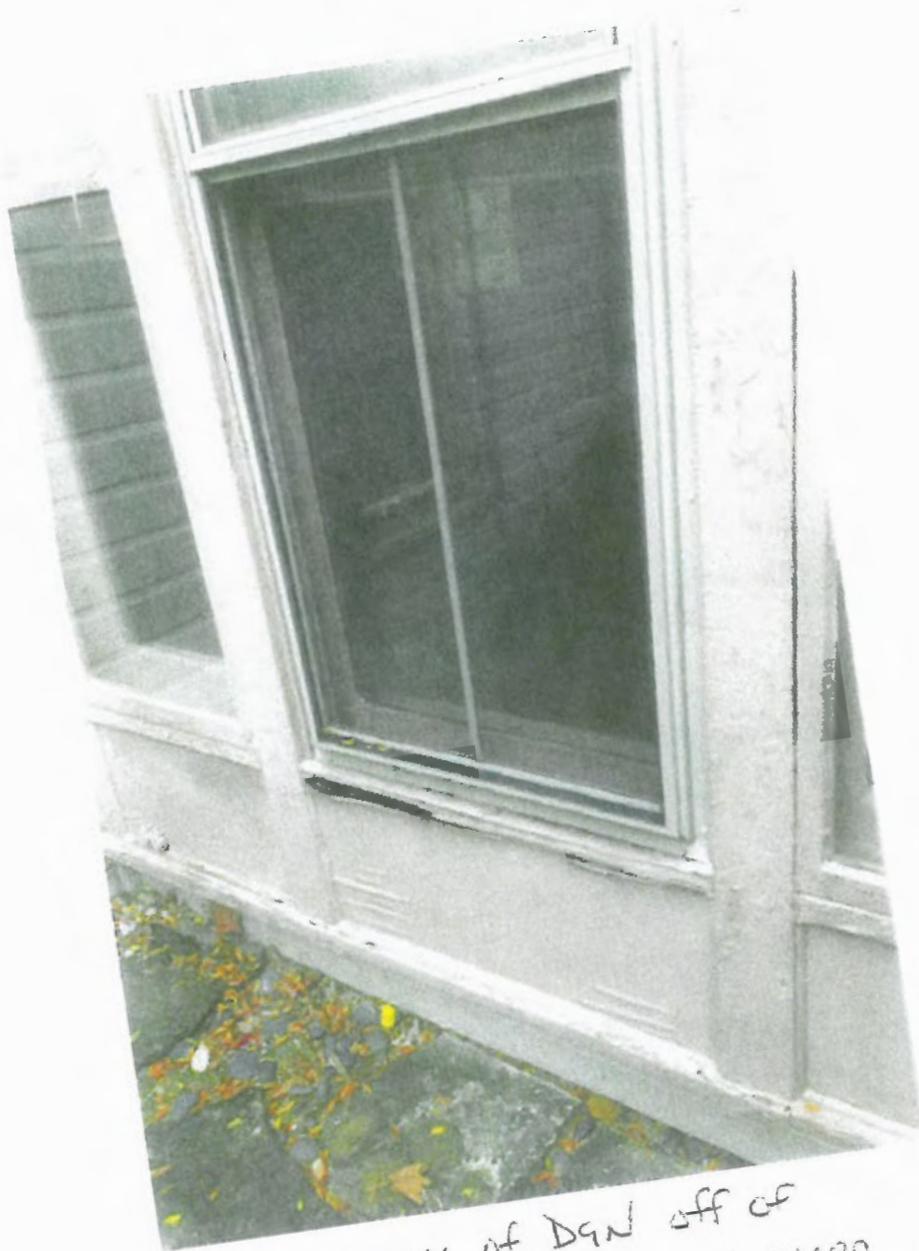
OUTSIDE WALL OF DEN OFF OF
KITCHEN (EAST WALL) ROTTING WOOD
PAINT

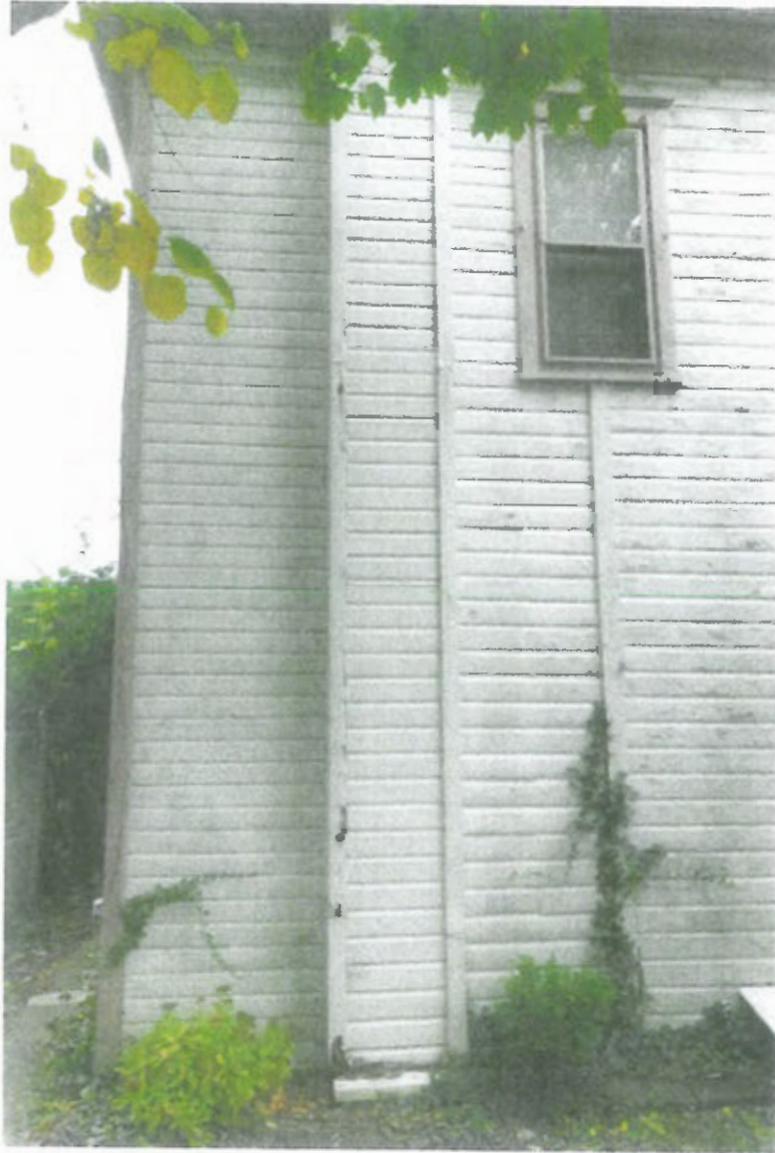
NORTH WEST CORNER OF BACK OF BUILDING
ROUTED FASCIA & TRIM BOARDS

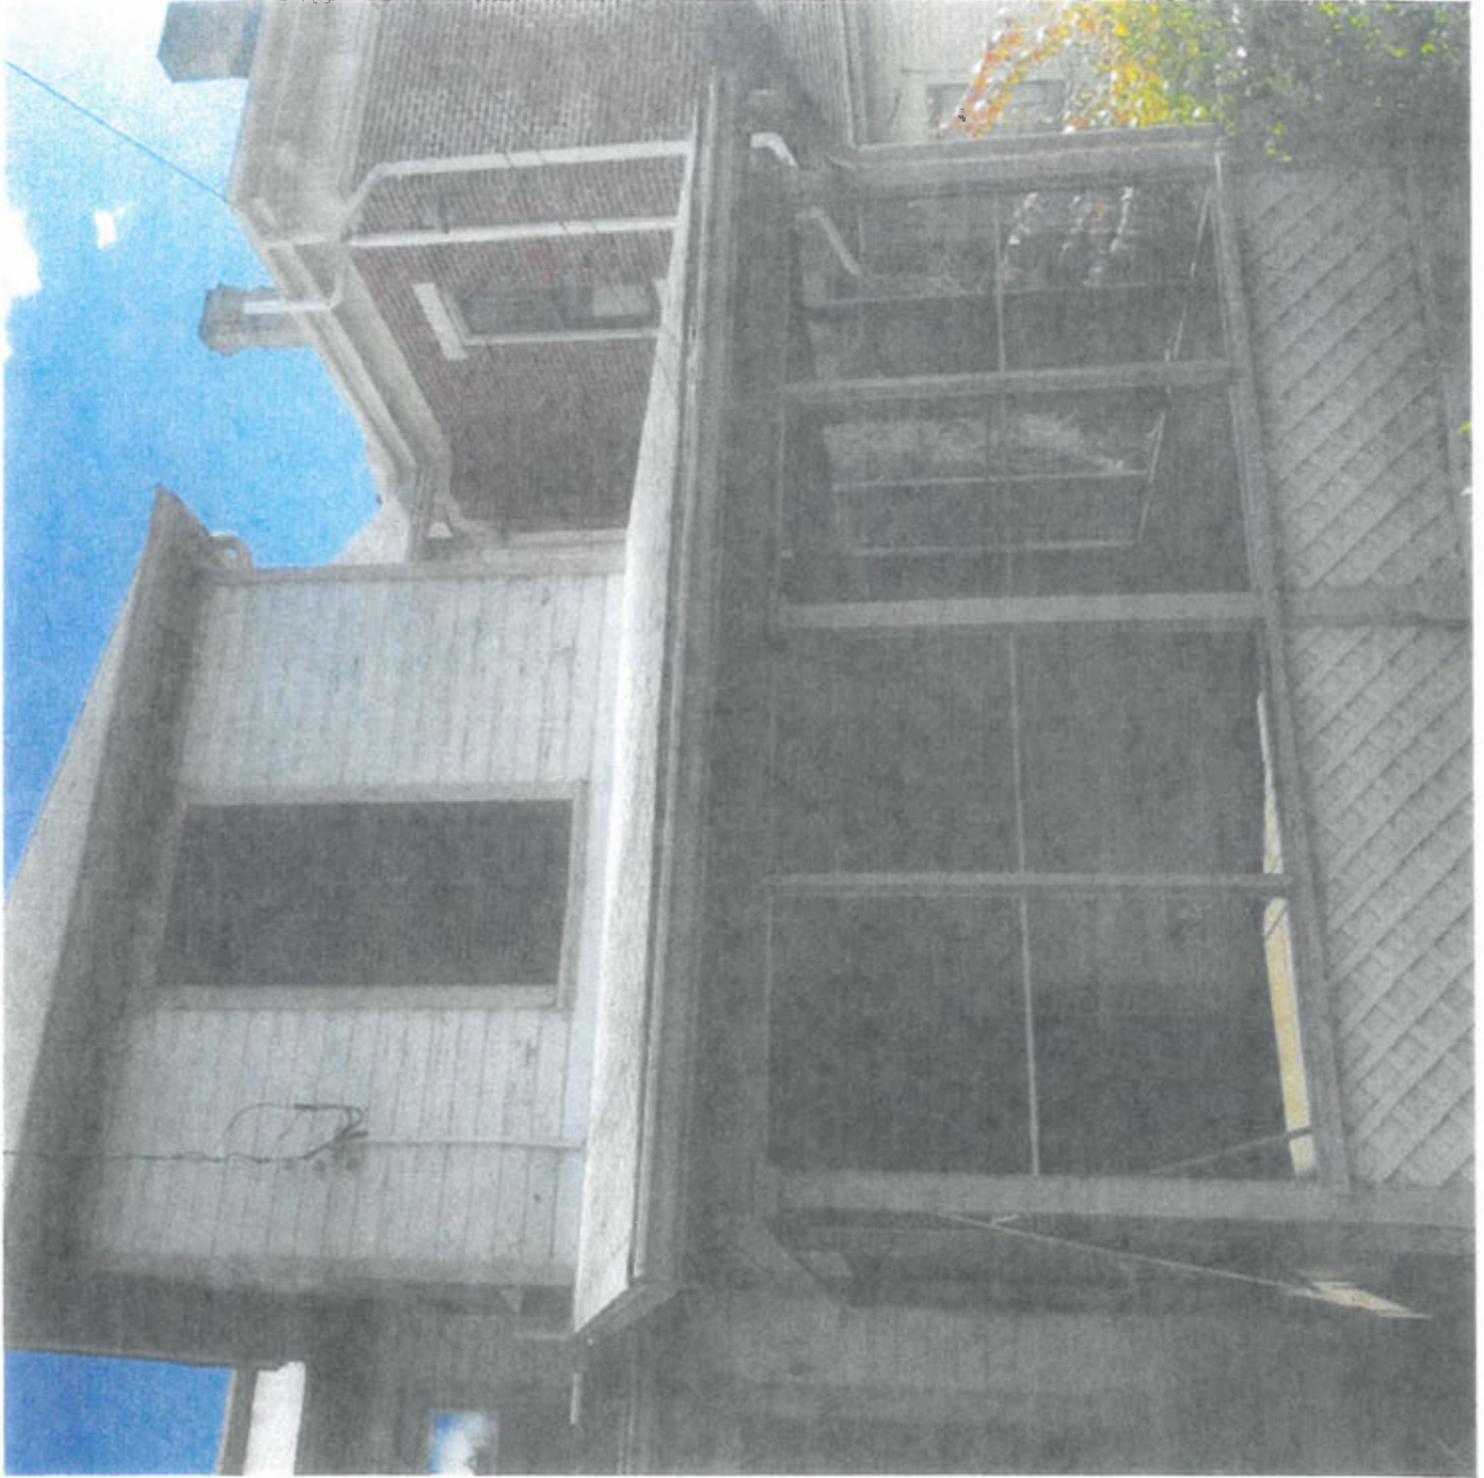
BACK SCREEN PORCH
W/ WEST SIDE OF
BUILDING
PEELING PAINT
ROTTED SIDING

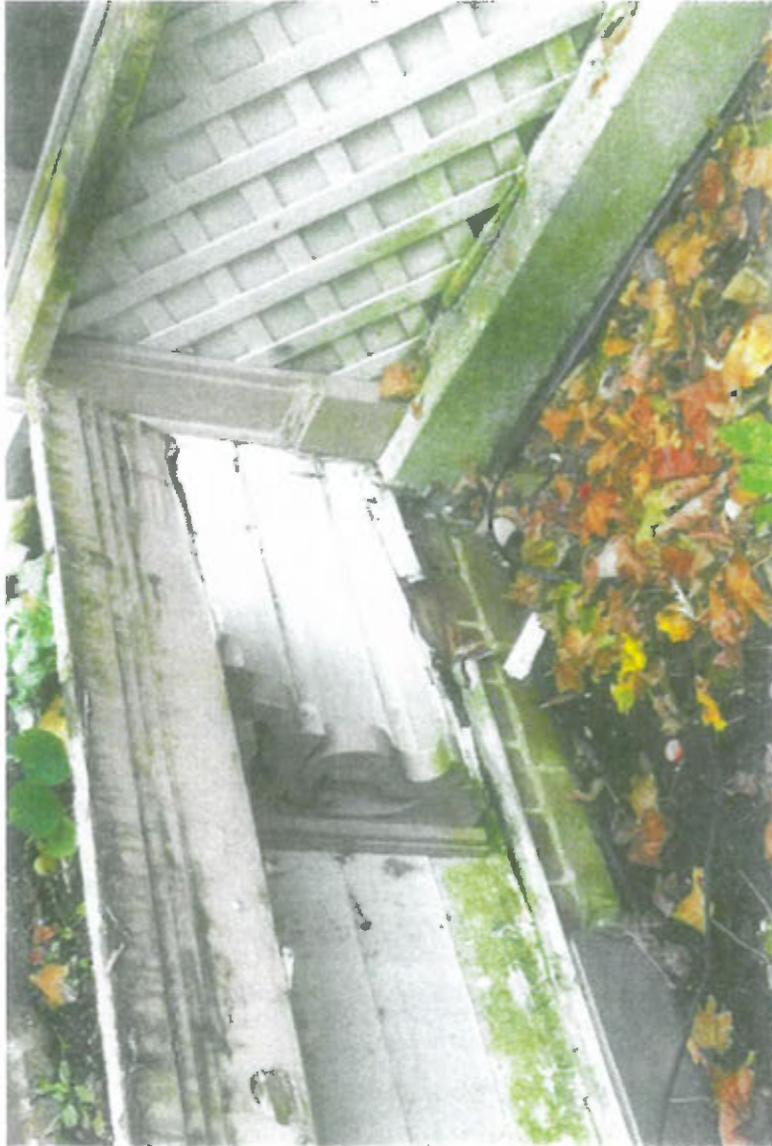
ROTTED SILL
PLATES & SIDING
ON BARK BECH
AT GROUND LEVEL

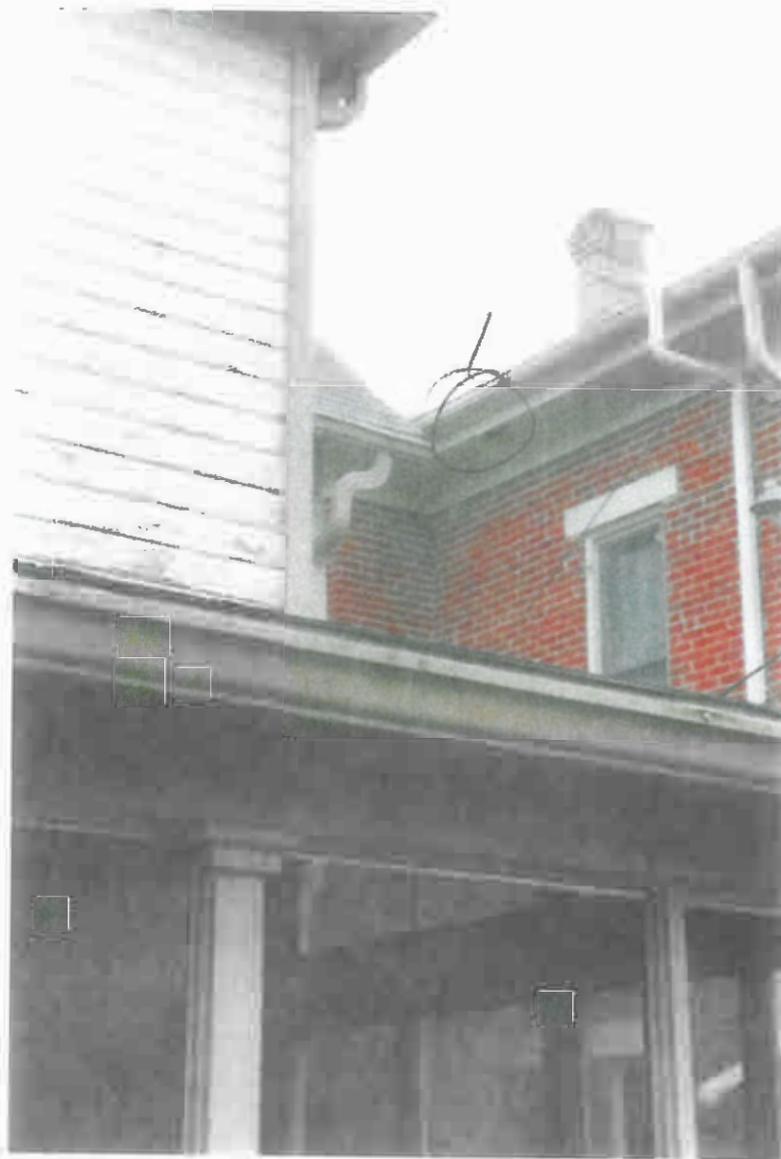
SOUTH WEST CORNER OF BACK OF
BUILDING - NOTE PAINT & POSSIBLE
WOOD ROT IN SOFFIT ADJOINING PROPERTY

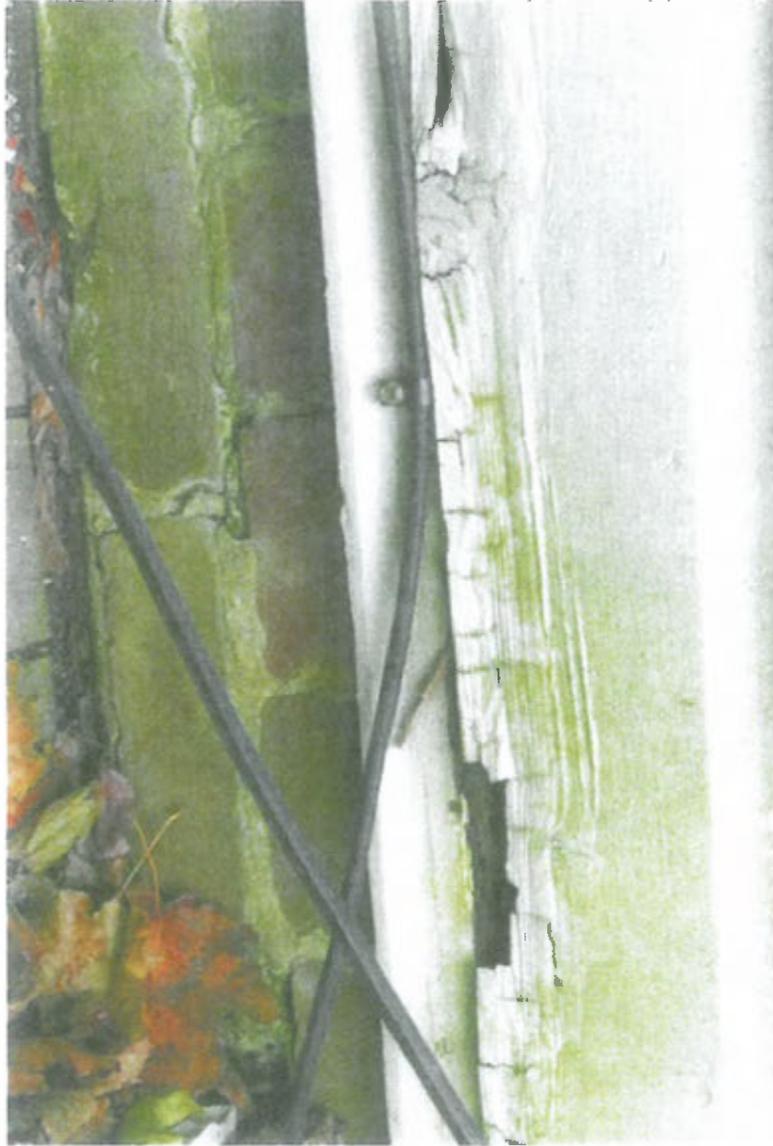
ROTTING SILL PLATE & SIDING AT
GROUND LEVEL

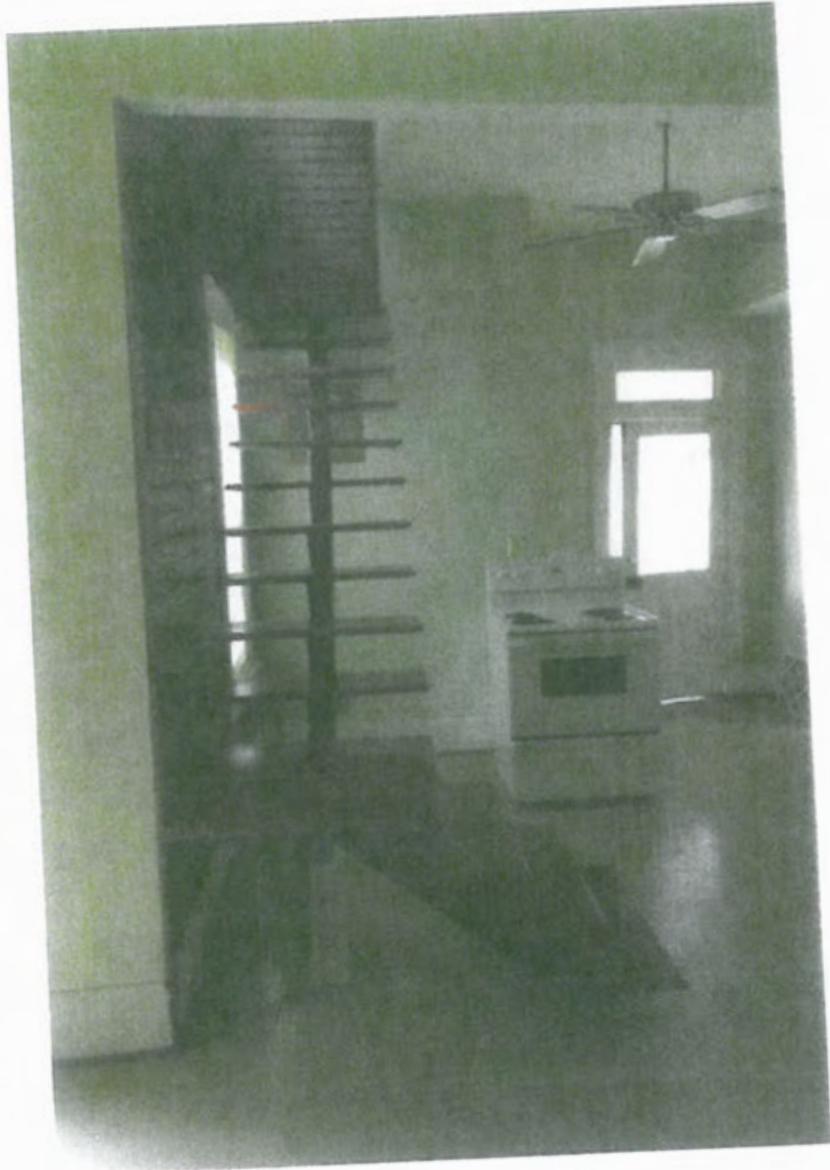
ILLEGAL STAIRWAY, (NO RAILING)
REMOVED BY TENANT
