**AGENDA - TROY PLANNING COMMISSION MEETING
WEDNESDAY, JUNE 10, 2020, 3:30 P.M.**

TO:	Troy Planning Commission
FROM:	Planning Staff
DATE:	May 13, 2020
SUBJECT:	Historic District Review: 126 South Cherry Street
OWNER:	First United Methodist Church
APPLICANT:	Linda Bosick, Trustee Chair

STRUCTURAL EVALUATION 126 SOUTH CHERRY STREET TROY, OHIO 45373

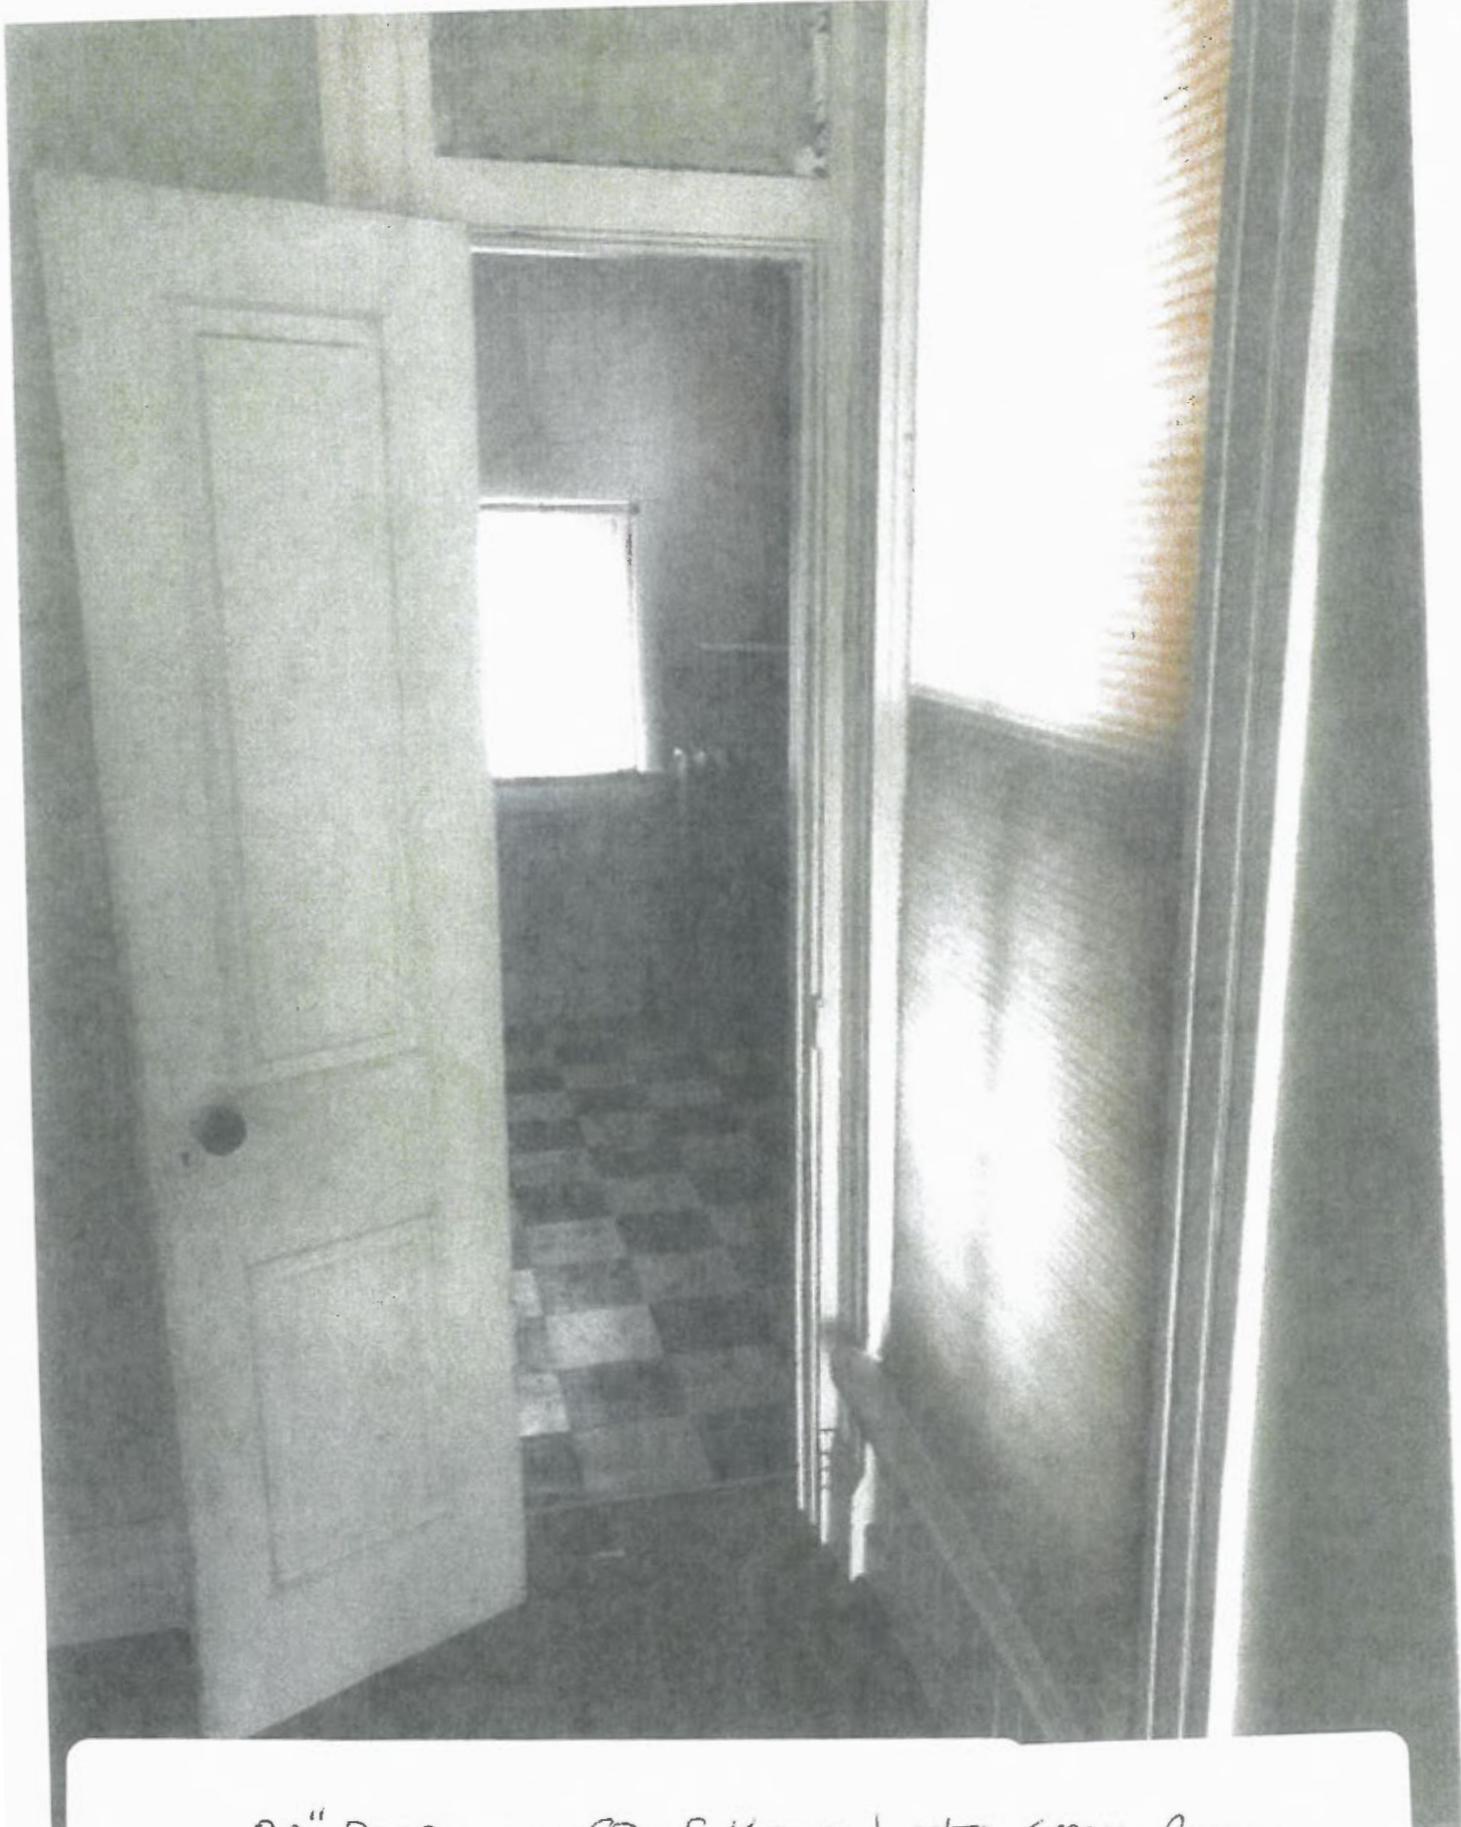
20" doorway off of KITCHEN INTO small room

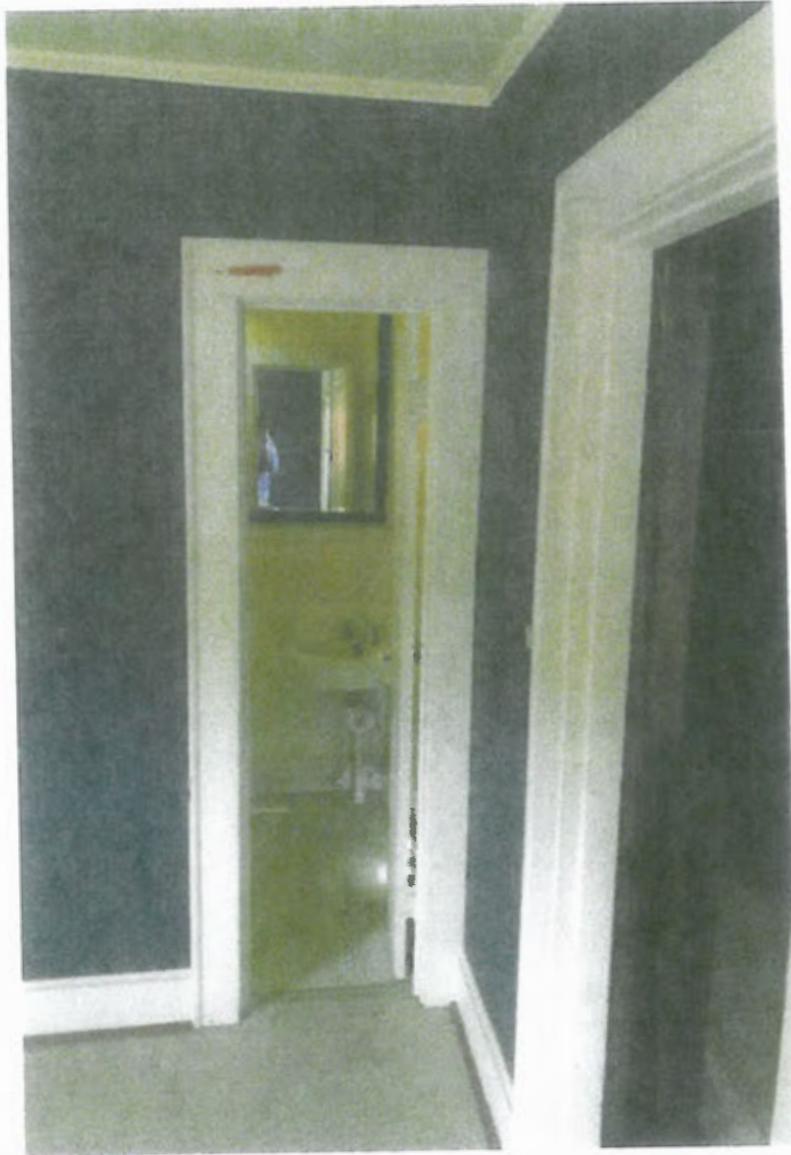
2ND floor SOUTH EAST Bedroom WITH SUBSTANDARD
ACCESS TO BATHROOM 20" DOORWAY

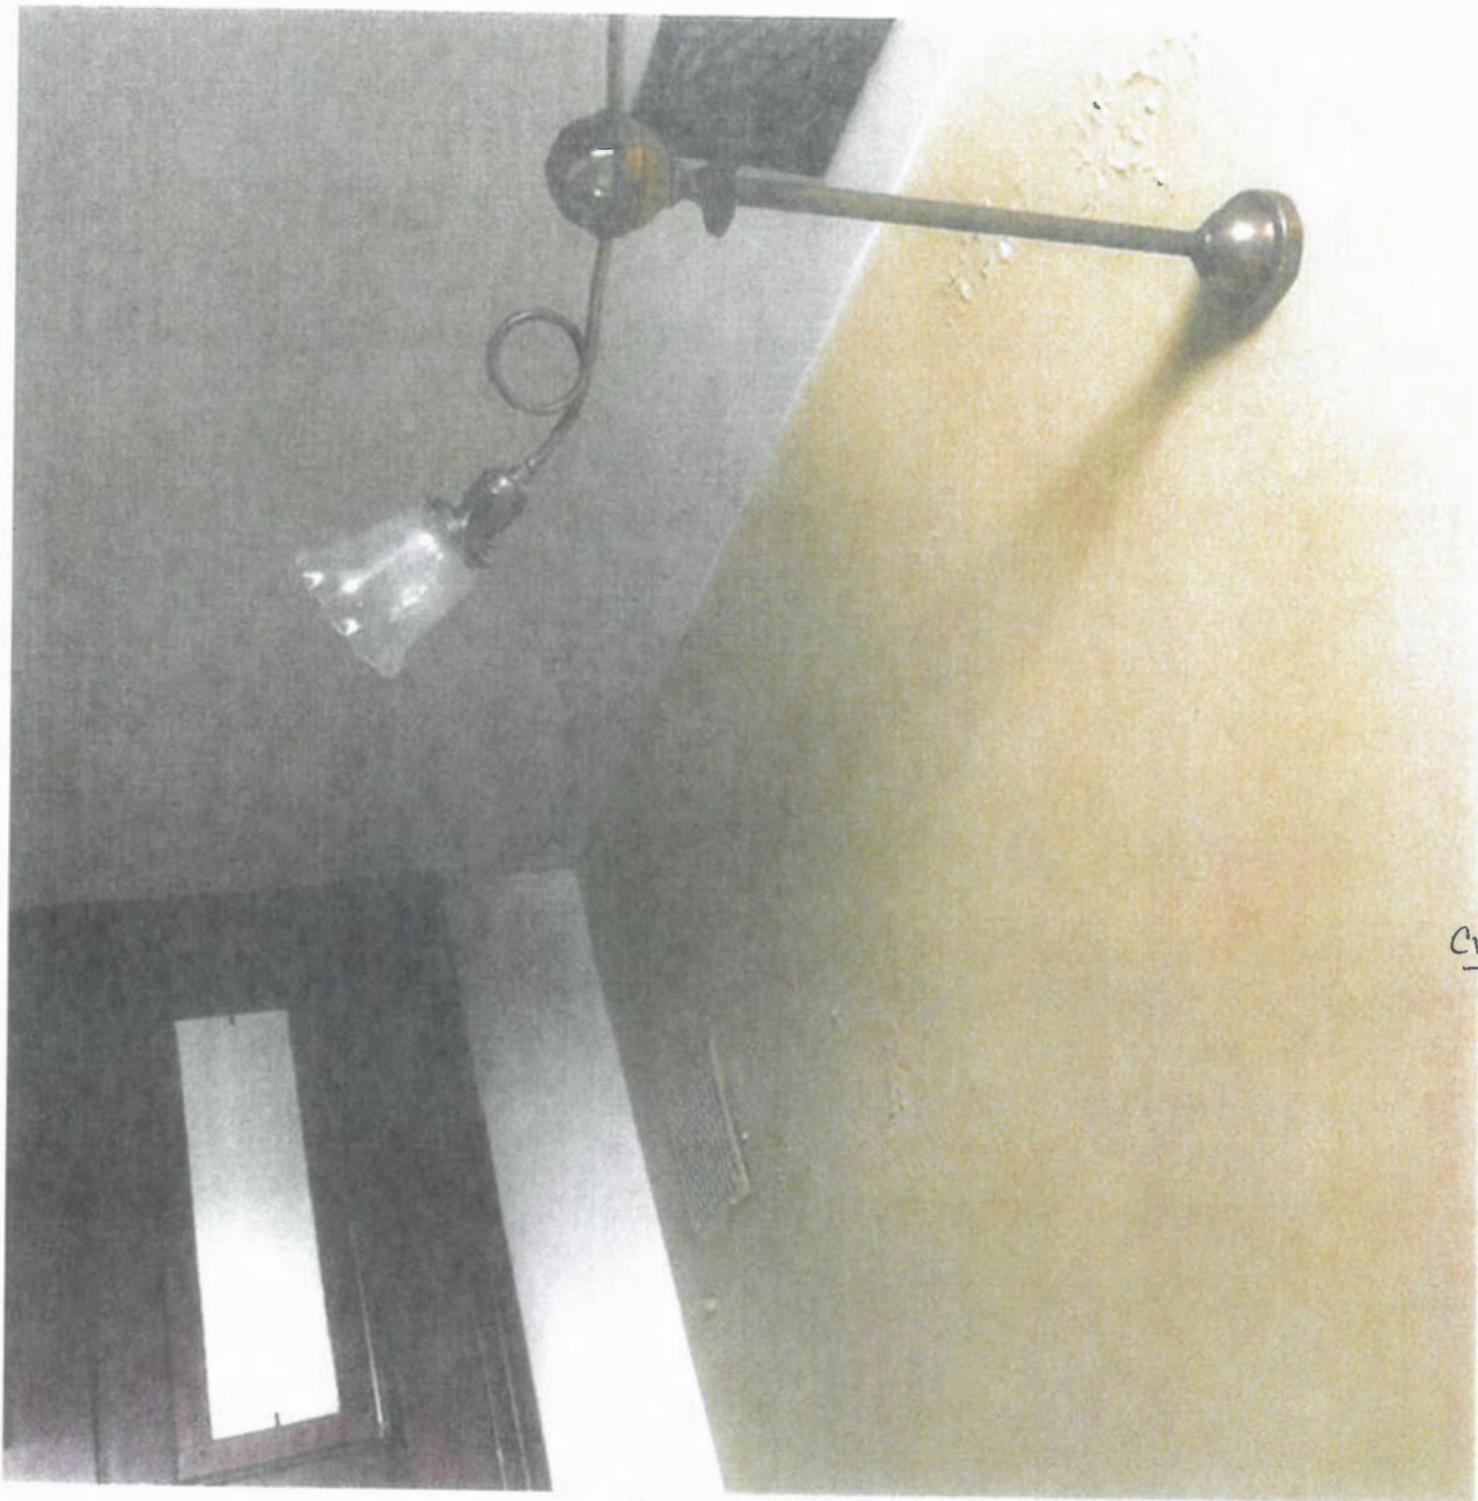
WATER DAMAGE, PEELING PAINT 2ND FLOOR ROOM

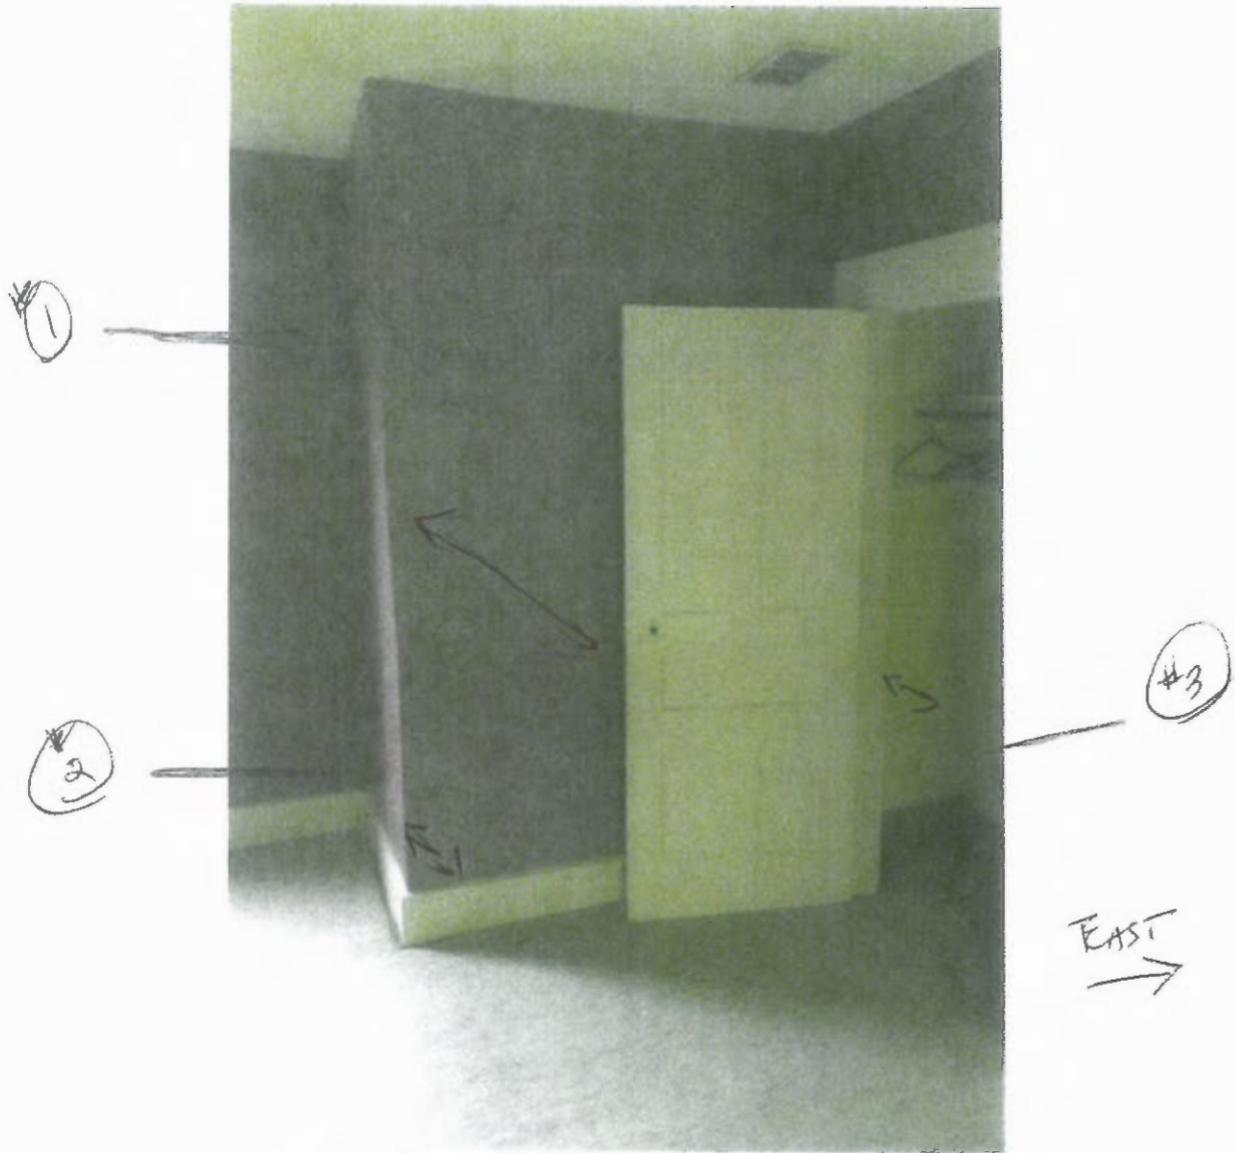
REAR BEDROOM WEST SIDE 2ND FLOOR
CRACKS IN WALL RUNNING EAST
SEE CLOSE UP PHOTO ACCOMPANYING

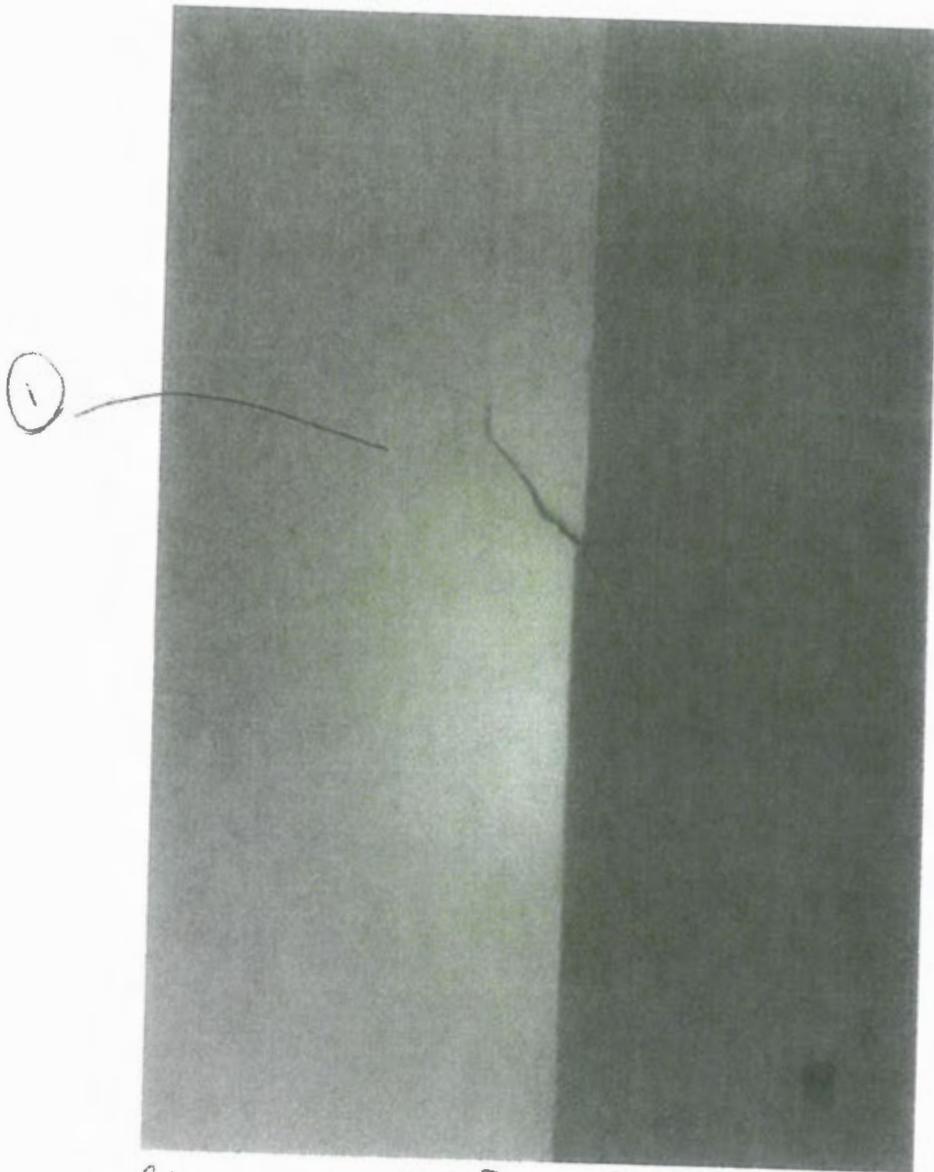
Cracks wall 2ND FLOOR Bedroom wall
APPROX. 1/8" +/- offset. Crack runs ENTIRE
LENGTH of wall TO THE EAST & DOWN THROUGH
CLOSET WALL

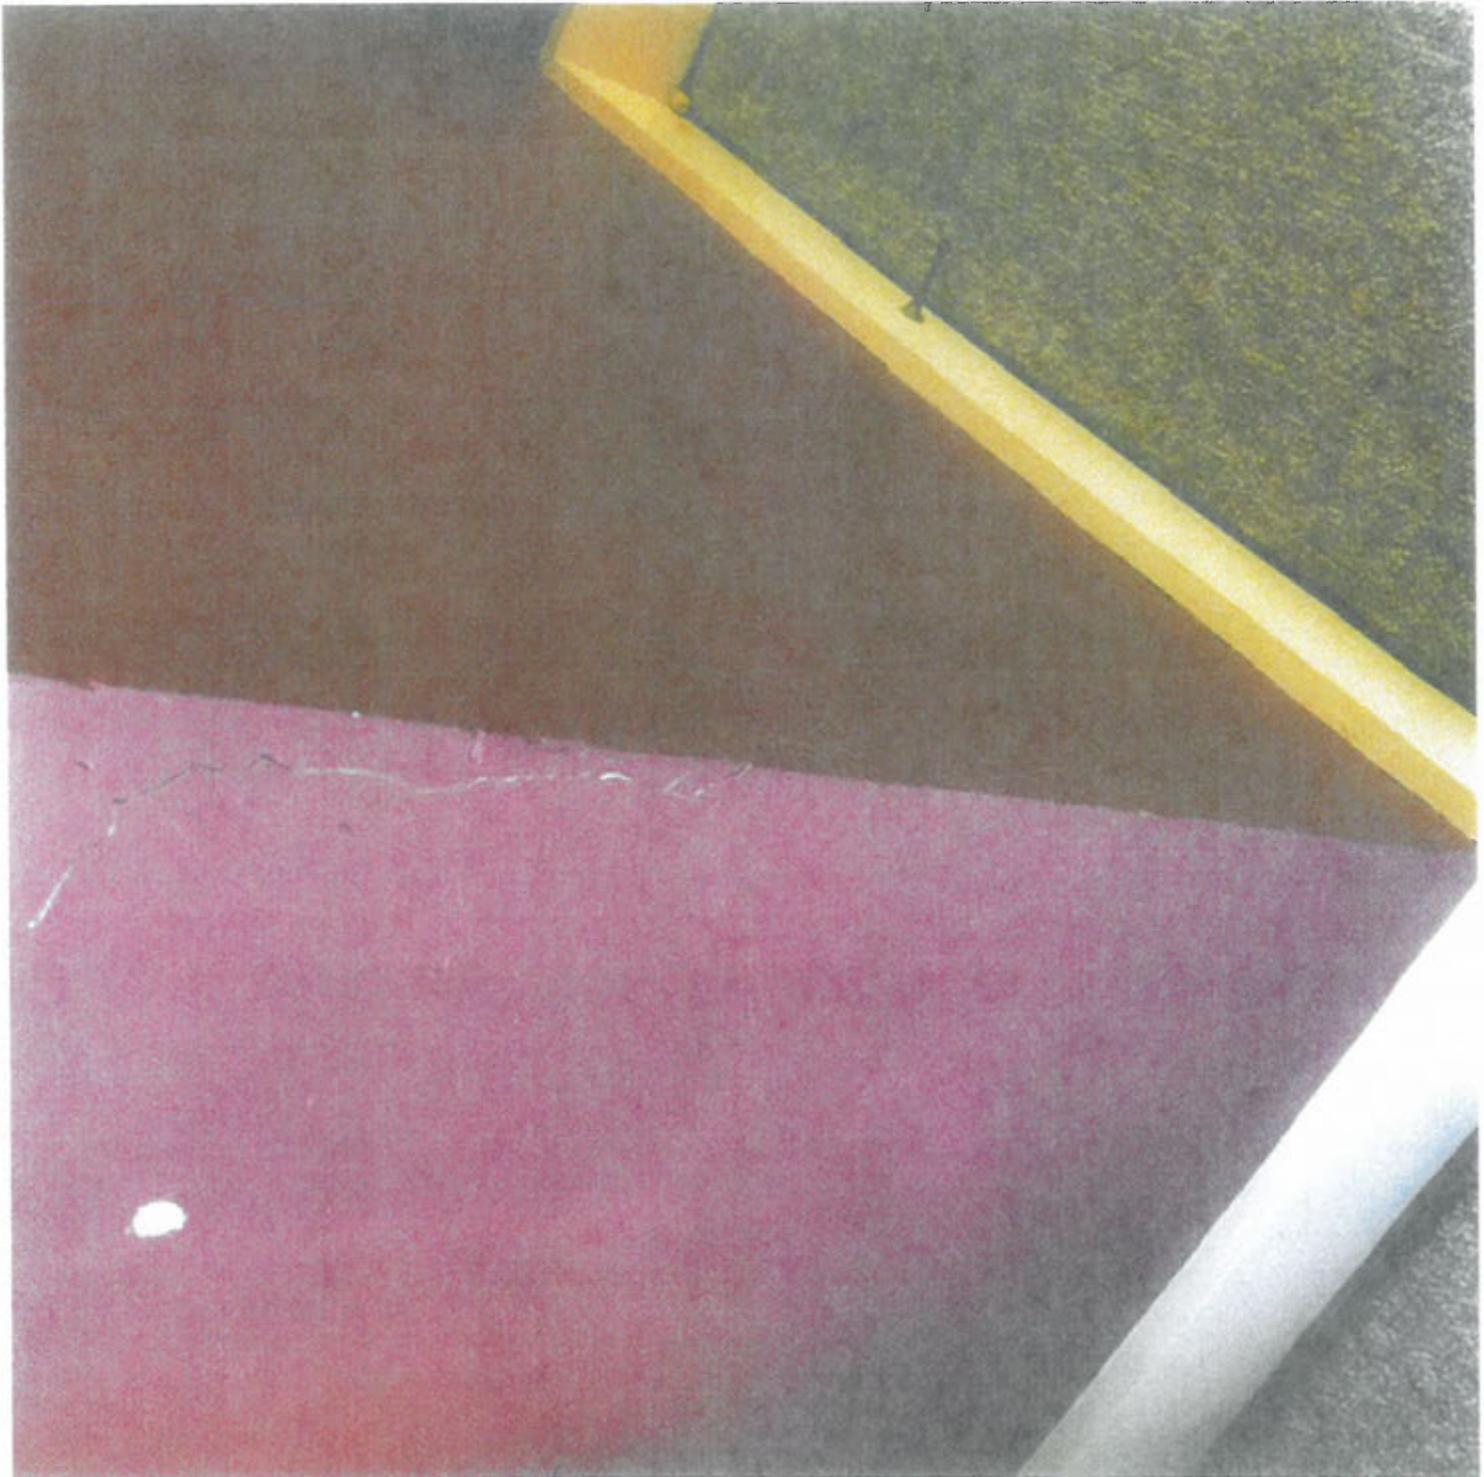
#2 lower crack in plaster wall

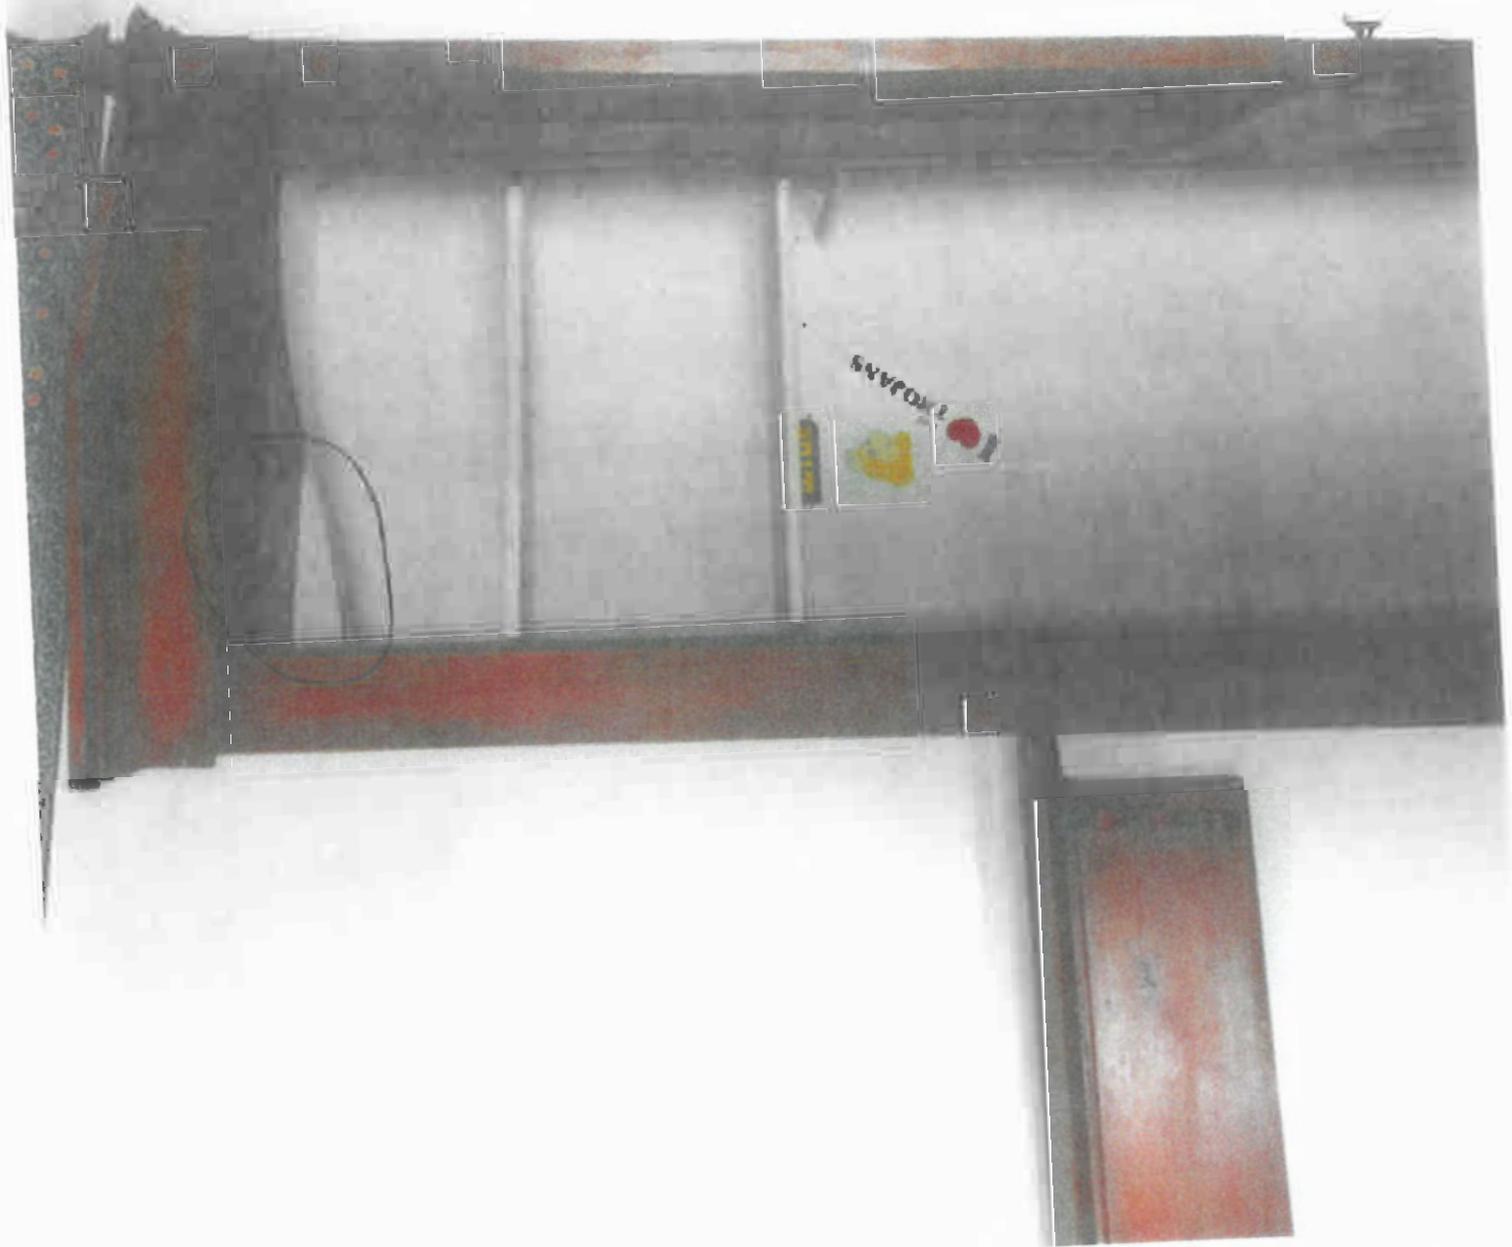
CRACK IN CEILING OF CLOSET APPROX. 1/4" GAP & DROP IN PLASTER

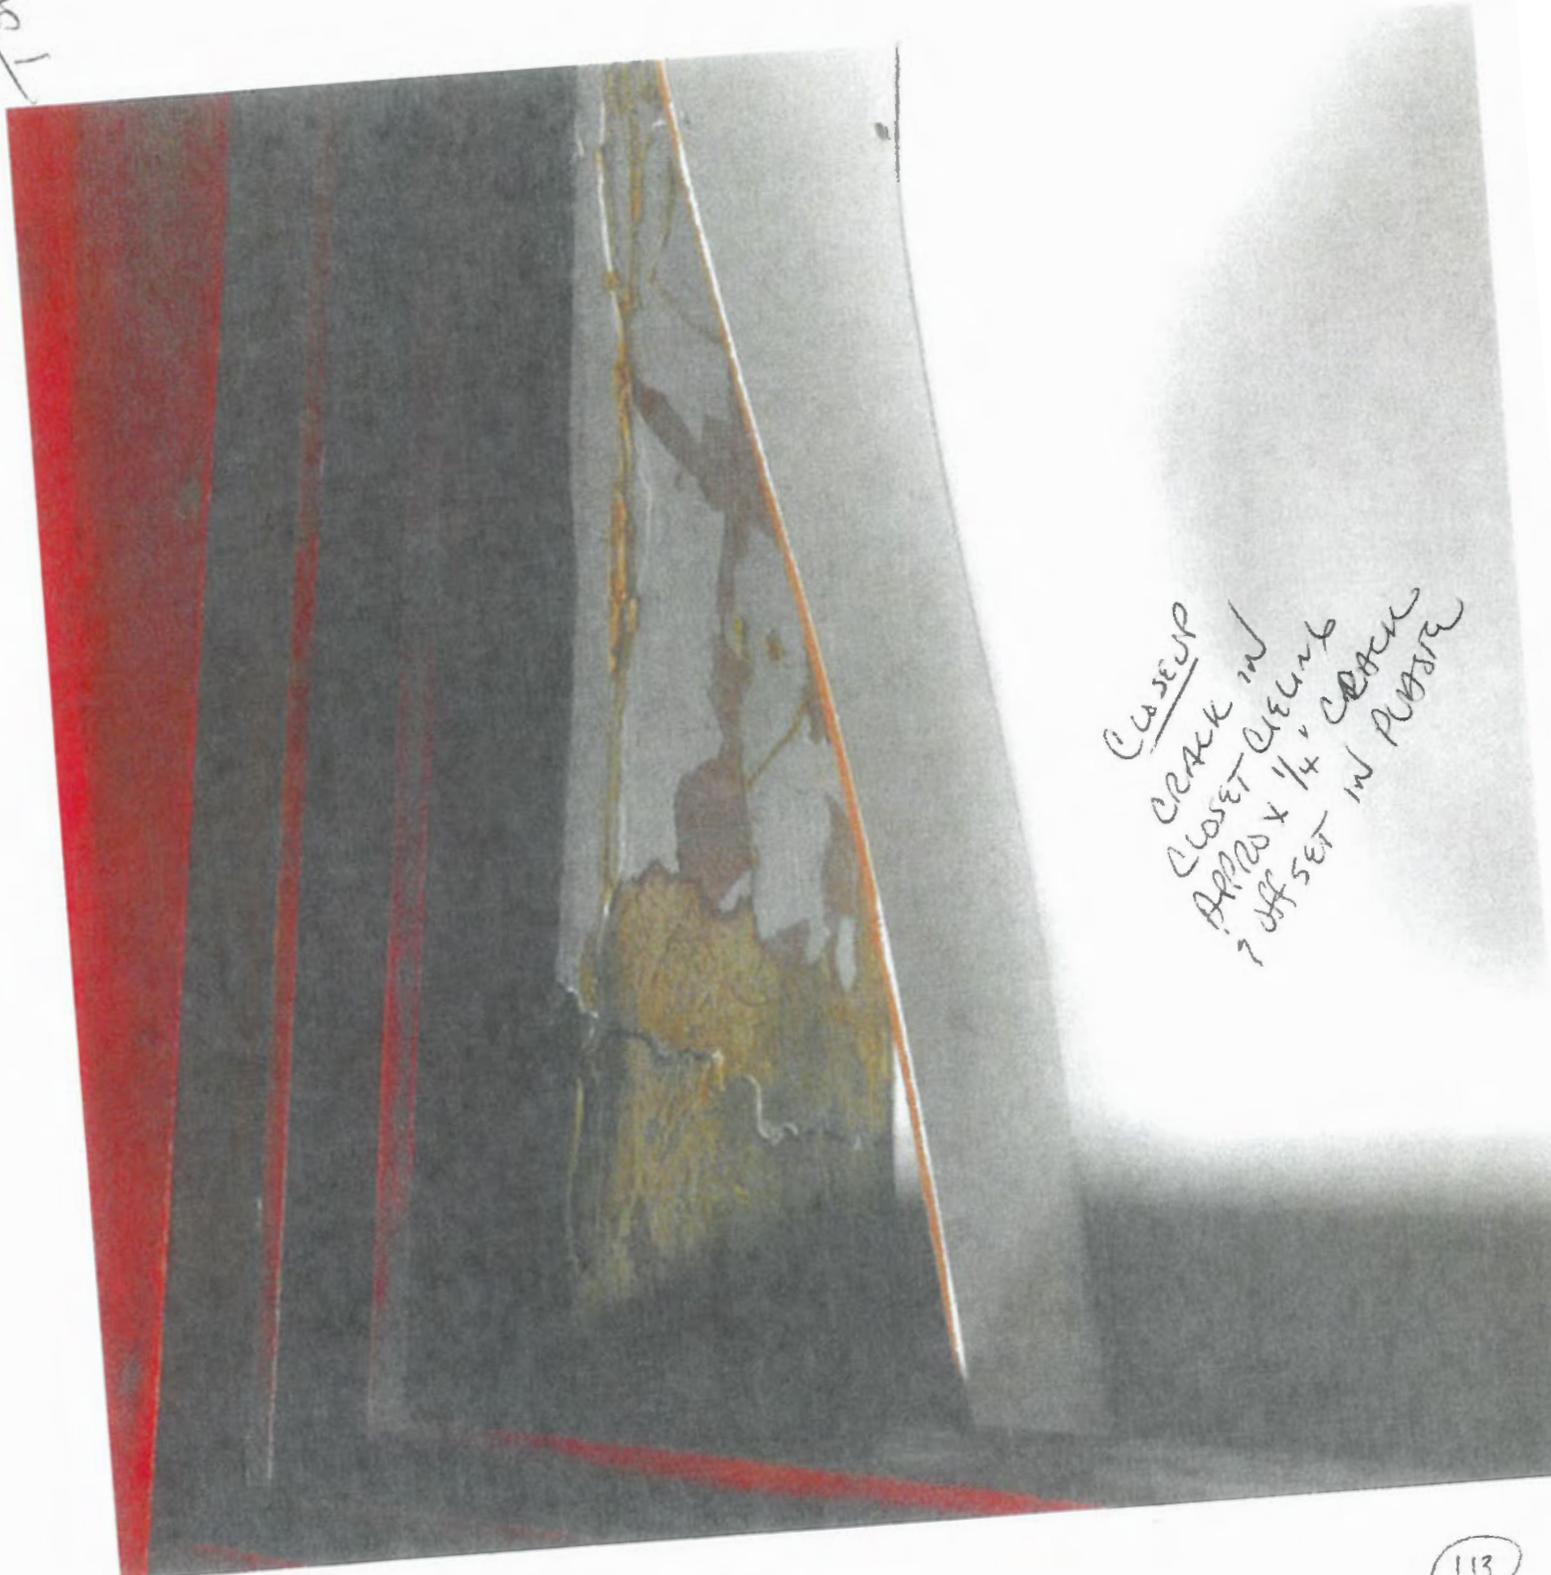
CLOSEUP
CRACK IN
CLOSET CEMENT
APPROX X 1/4" CRACK
? OFFSET IN PLASTER

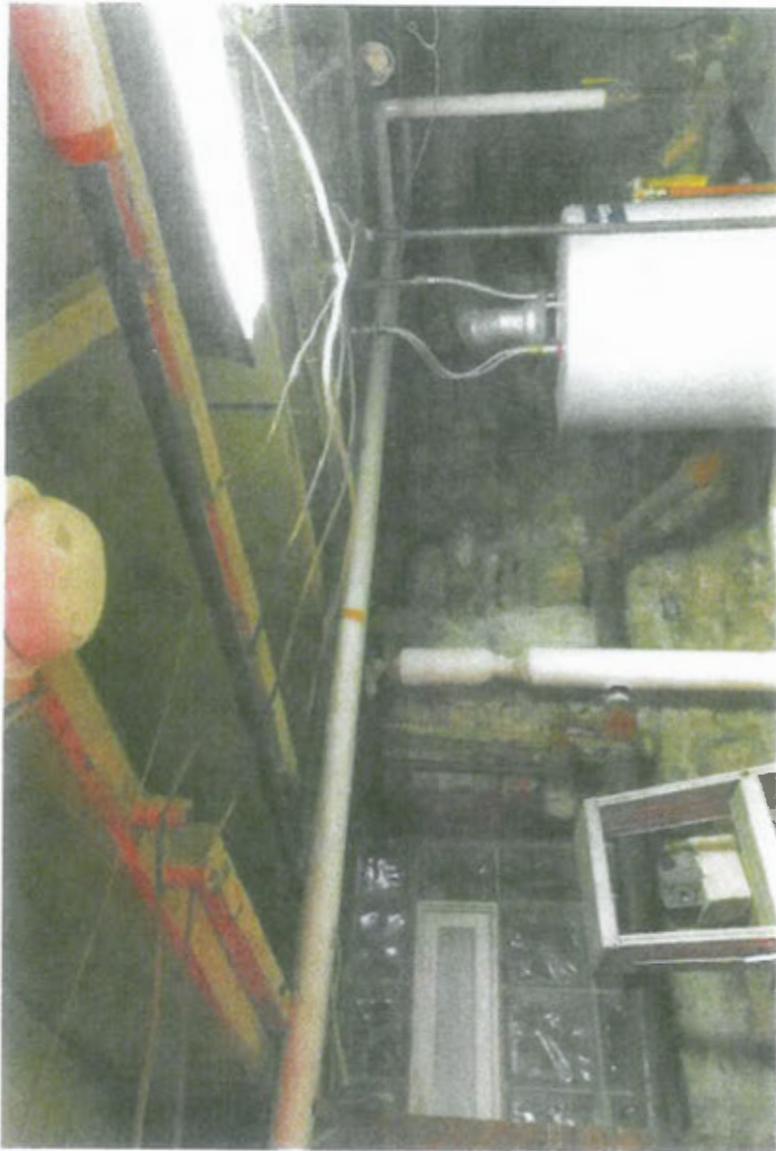
Basement Exposed Knob & Tube wiring
with exposed Romax wiring

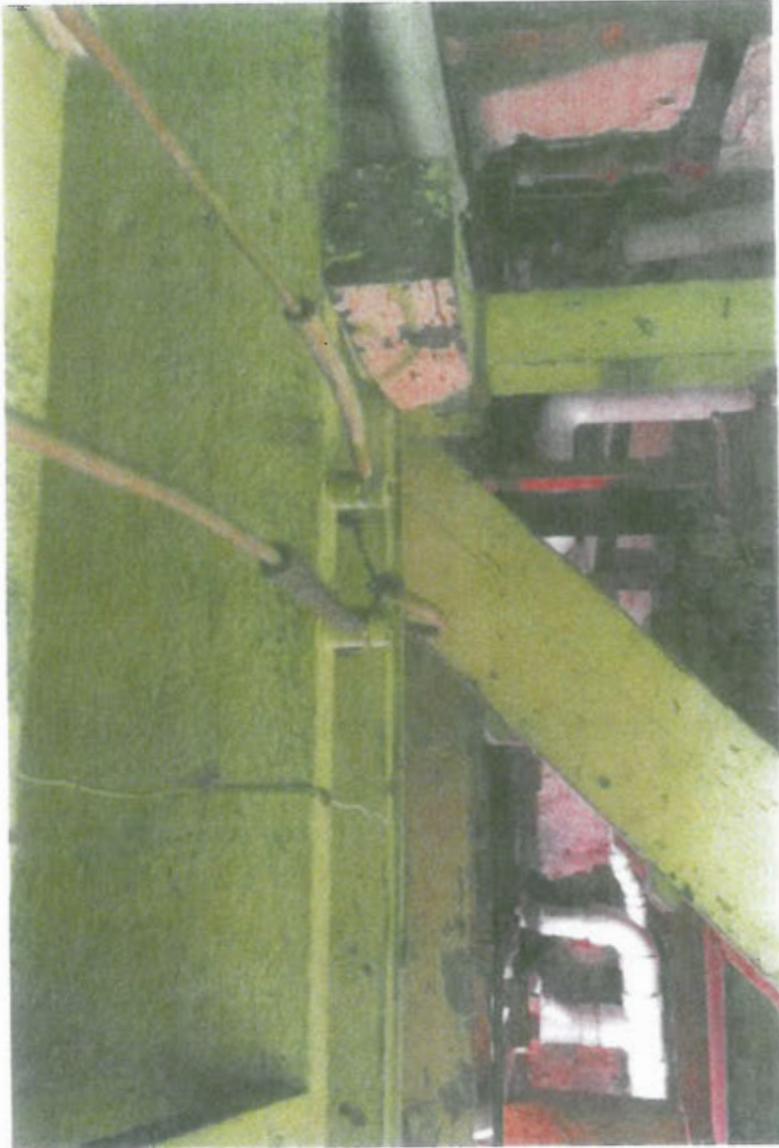
KNOS AND TUBE WIRING NEAR STAIRWELL
IN BASEMENT

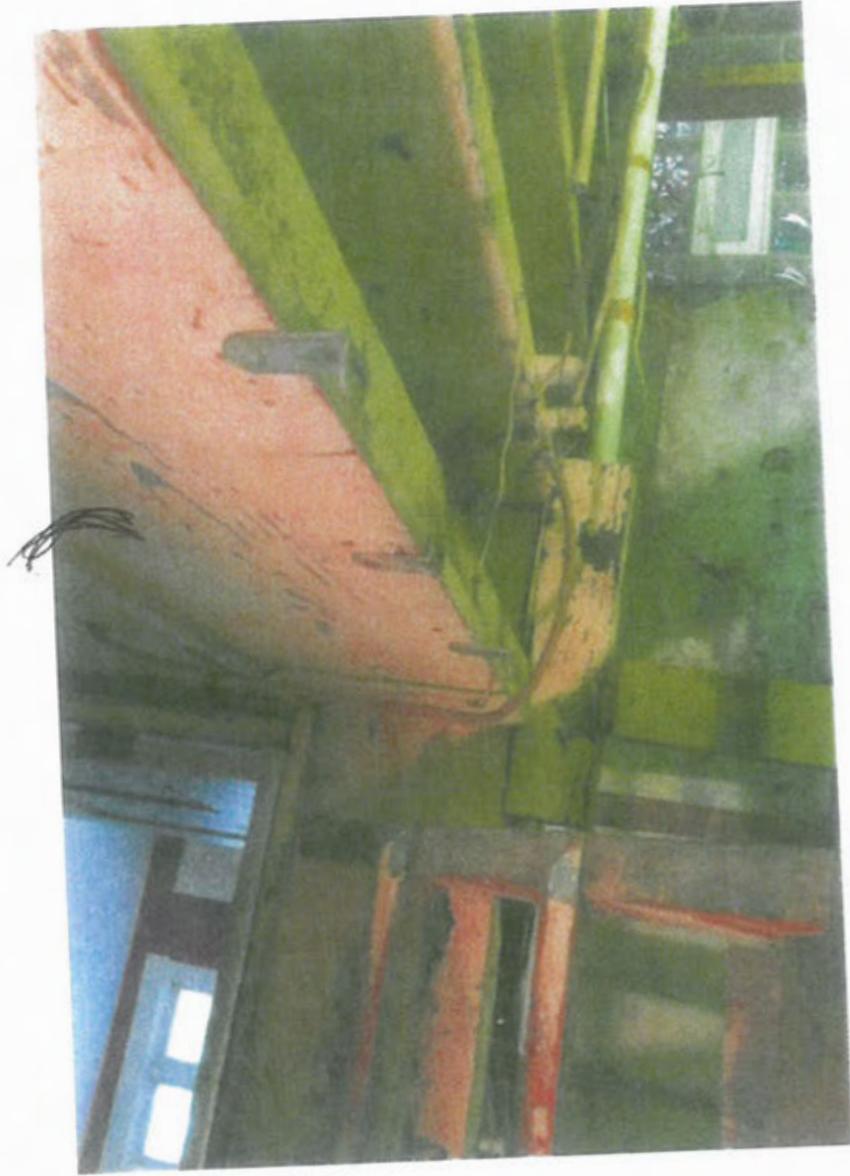
STAIRS
TO KITCHEN
KNOX TUBE
WIRES
RUNNING
THROUGH
DRYWALL

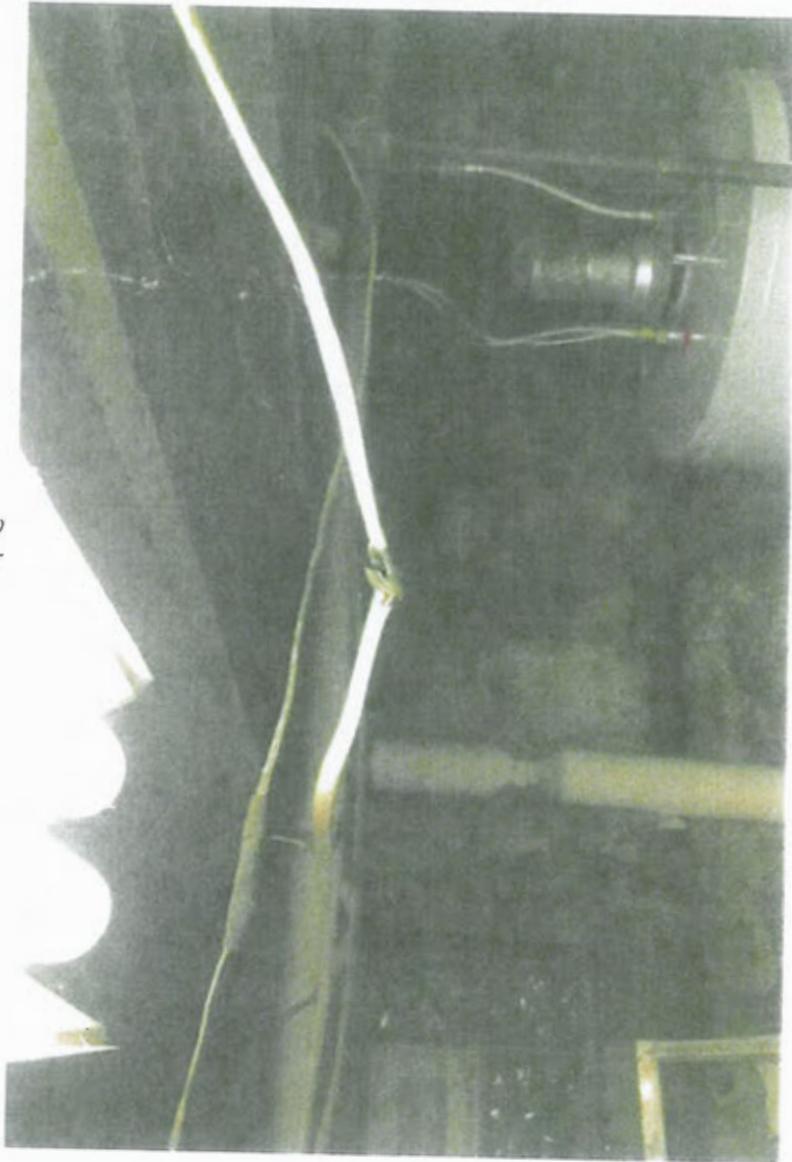
CUT ROMEX WIRING IN BASEMENT

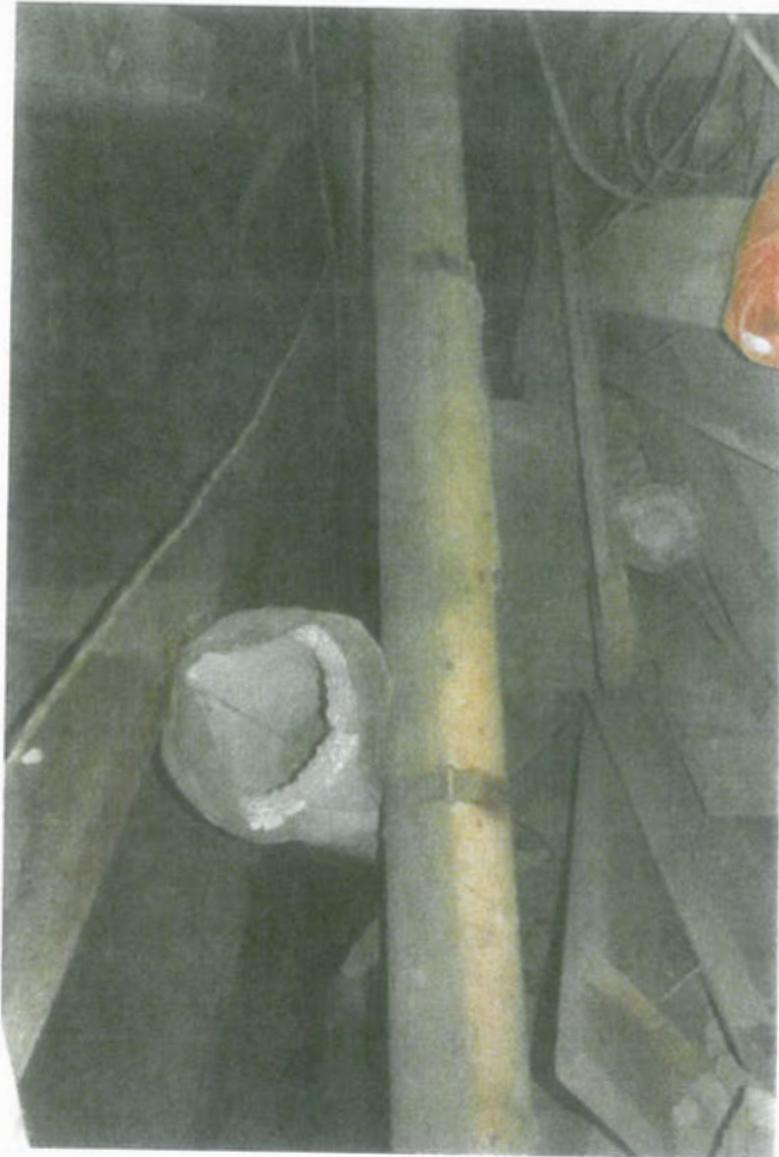
ASBESTOS INSULATION IN BASEMENT CRAWL SPACE
PIPE INSULATION

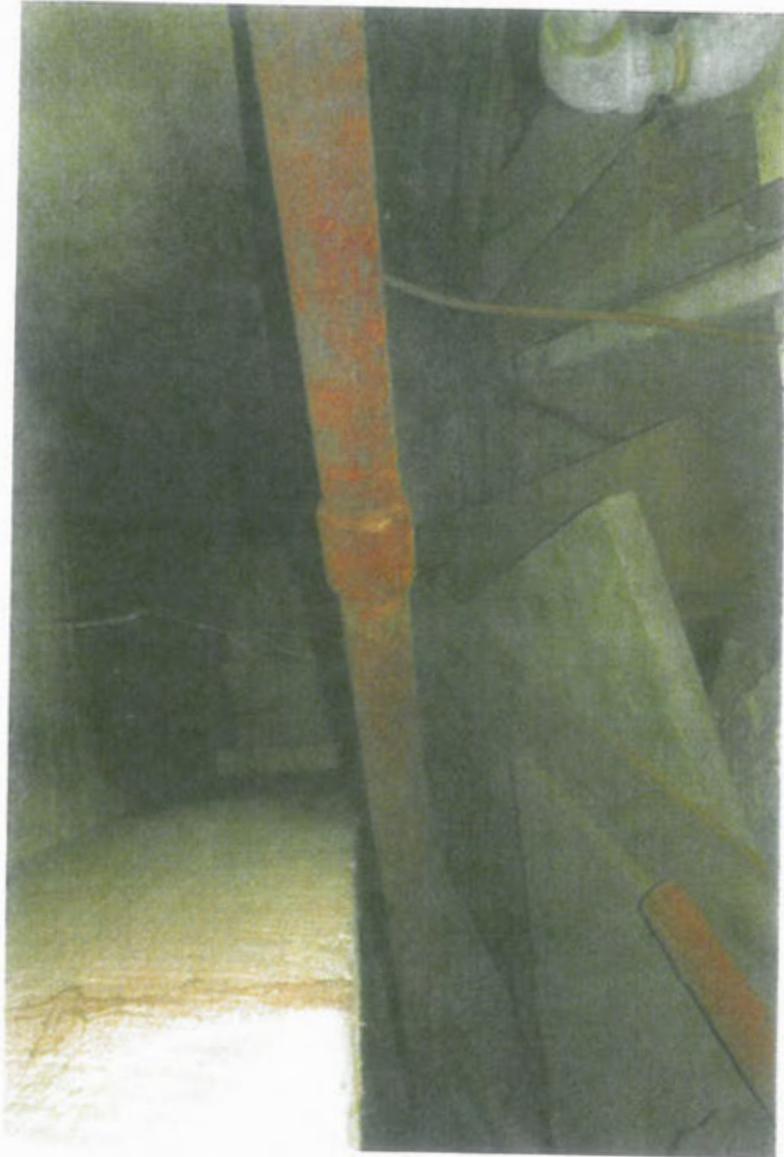
WATER PIPE IN BASEMENT CRAWL SPACE
