TO:	Troy Planning Commission
FROM:	Planning Staff
DATE:	October 8, 2020
SUBJECT:	Historic District Review-Demolition: 112-118 W. Main Street
OWNER:	116 West Main LLC
APPLICANT: 116 West Main LLC – Randy Kimmel

RE: Building Evaluation  
Tri-Tech File #20376

TAVERN DRAWINGS

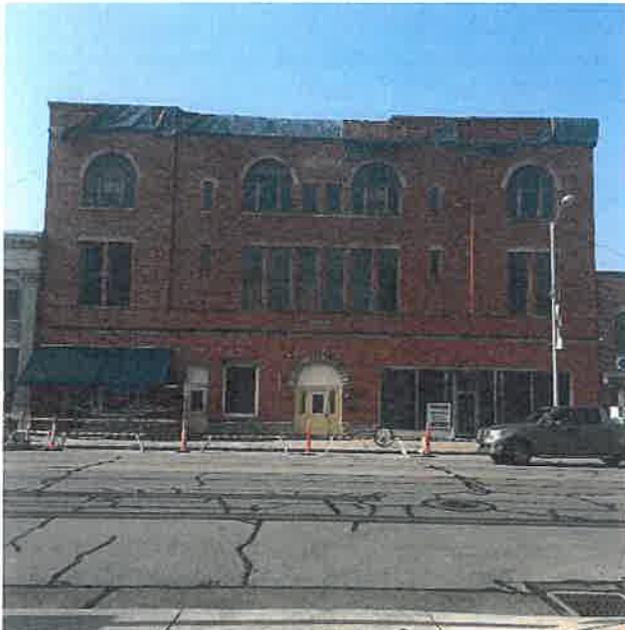
Per Mr. Redick the original structure was constructed in 1841. In 1902 a partial demolition of the north section of the building was done with an addition constructed to the north, east, and west of the original.

The buildings are constructed of wood framing supported by multi-wythe brick masonry walls and some wood wall framing. The roof of the original building is supported by timber trusses that span from the east to west exterior walls. These trusses are assembled with mortise and tenon connections.

Failures of the roof trusses over the original building were observed. Truss members are broken, and truss connections have failed.

Portions of the roof structure over the 1902 addition have separated and lifted off its supports. The roof diaphragm connections to the masonry shear walls have been broken at these locations as well.

The load bearing brick masonry walls of the original building and the 1902 addition have deteriorated extensively and been damaged by a storm where the parapet was torn from the building.

The floor structure exhibit signs of damage, but direct inspection of the floors could not be obtained during my site visit.

Structural failures have occurred at the roofs, diaphragms, the masonry walls, and possibly some of the floors. All these elements are critical to the stability and capacity of the building to support the required loads. It is my professional opinion that the structure be vacated and barricaded until the building can be demolished or the repairs to the structure are made.

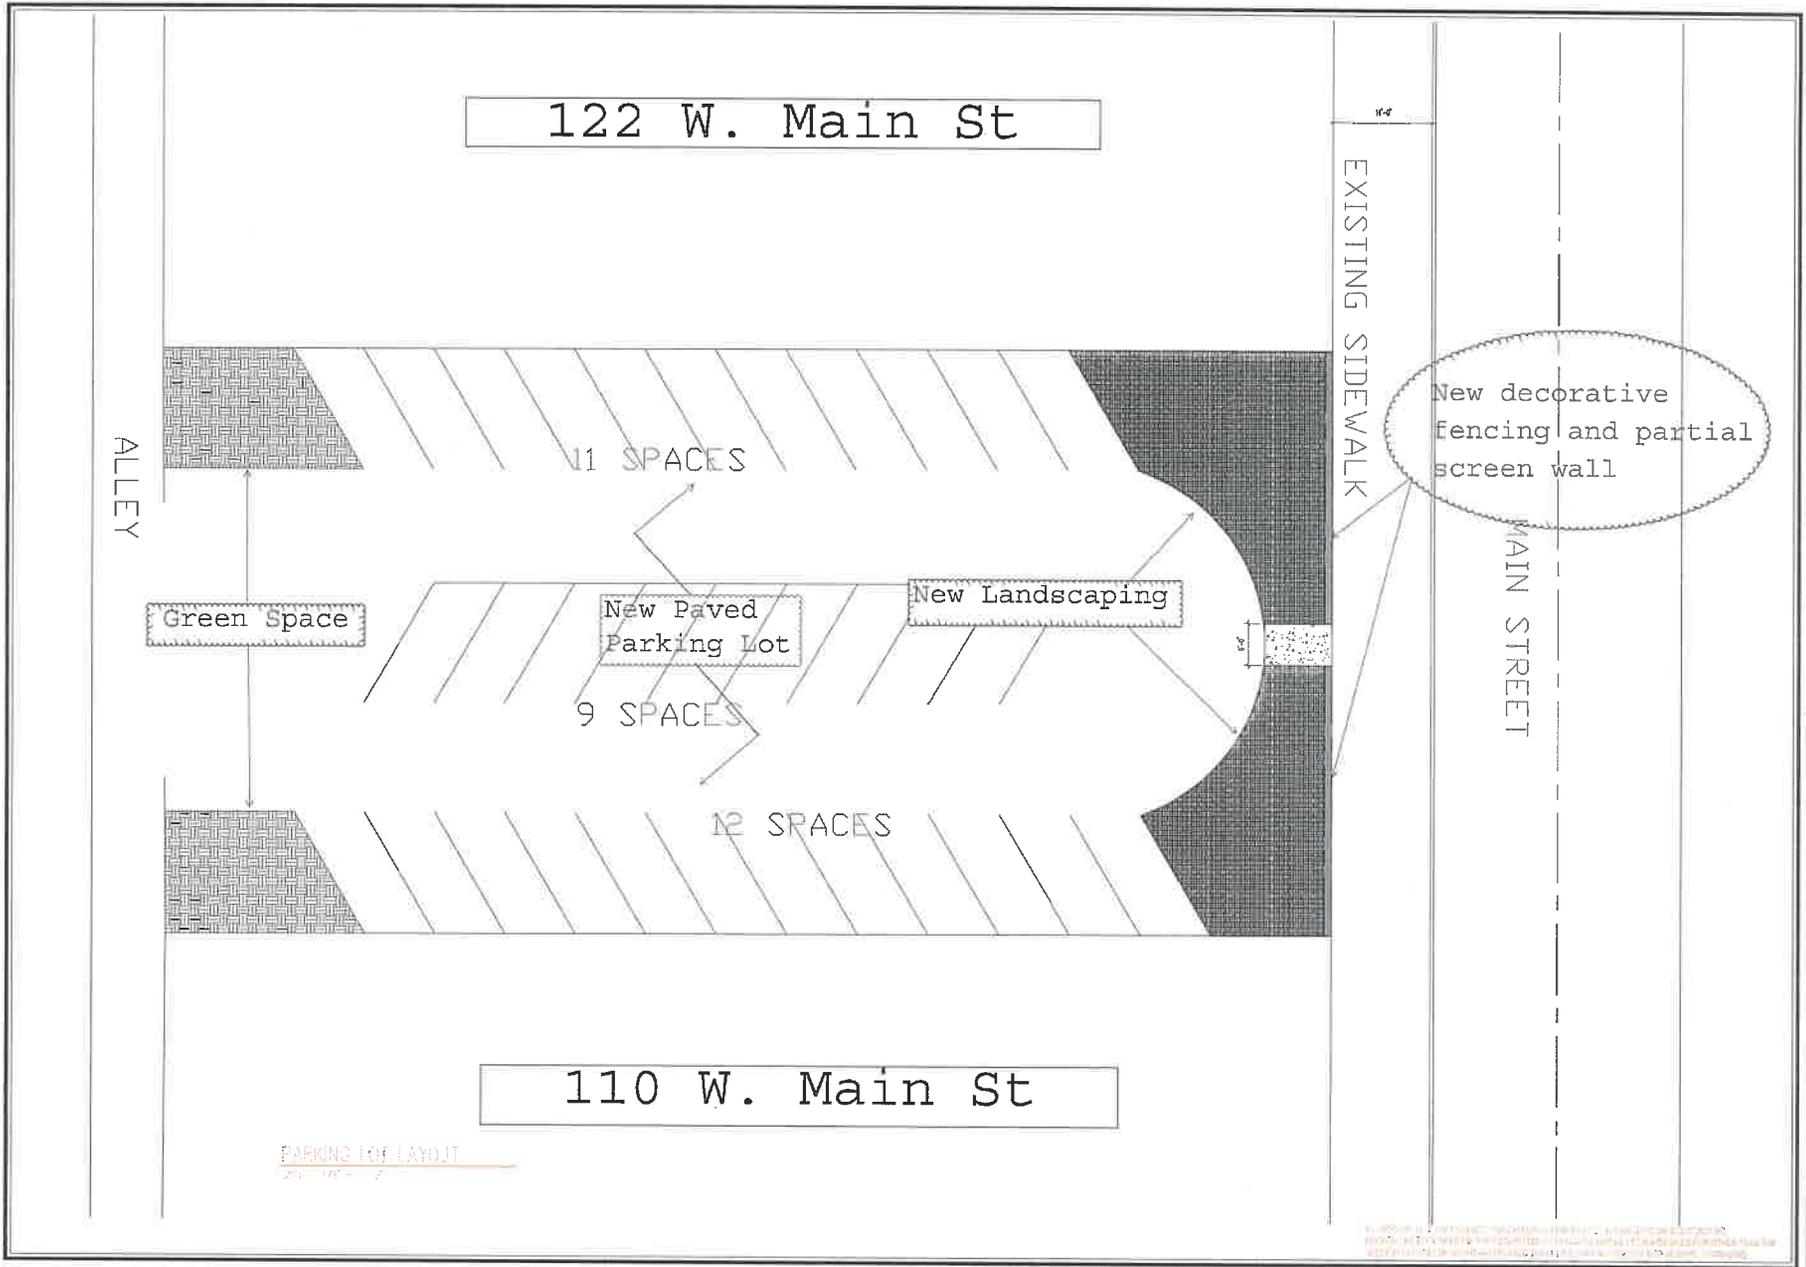
EXHIBIT D

Immediately following demolition, we will install a parking lot that will require a pay-pass to park onsite. The parking lot will be complete professionally, and will include approximately 15% greenspace consisting of a landscape "buffer" between the sidewalk and the edge of the parking lot. The landscaped areas will conform with the Architectural Design Standards and City of Troy parking lot standards, and include incorporation of the existing building's limestone and will display the existing plaque mounted on the front of the building. Please note the installation of the parking lot is dependent on the schedule of closure for asphalt plants. If the plants close prior to the ability to install the parking lot, we commit to install the parking lot upon the reopening of the asphalt plants in the spring.

- Includes paved area per drawing
- Includes new striping
- Includes landscape islands/buffers as shown
- Includes partial, decorative screen wall along Main Street
  - Incorporating as many limestone pieces from the original structure as possible
  - Includes re-install of plaque from the original structure.
