**Troy Aquatic Park
Assessment/Feasibility Study**

The City of Troy
September 5, 2024

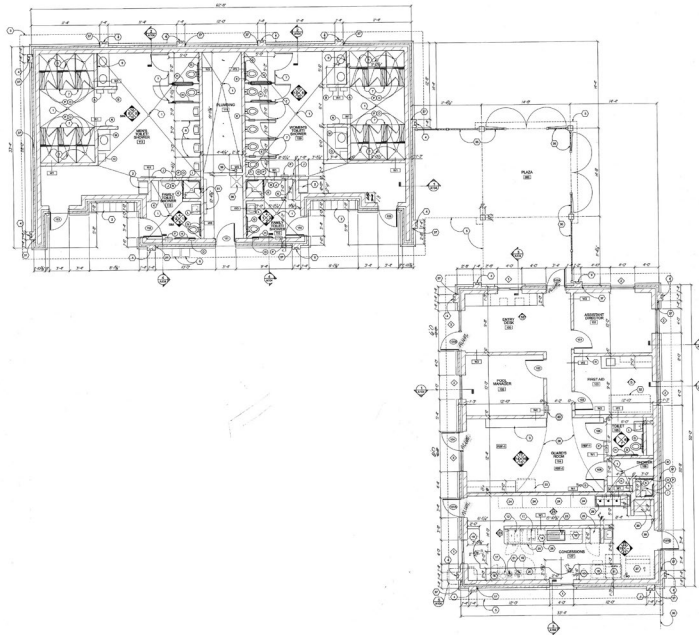
Bathhouse Building Plan

The men's and women's toilet/shower rooms are both equally sized with six fixtures (WC and Urinals) each, six showers each, and three lavatories each. In addition to the gender-specific locker room, there are two individual family restrooms each with one shower, one lavatory, and one water closet. Lockers are provided on the exterior of each toilet/shower as well as within each of the locker rooms and should be replaced as they are quickly reaching the end of their useful life.

Both the Men's and Women's toilet/shower rooms are adequately sized to serve a pool facility of this size. The toilet/shower rooms are ADA compliant and align with current building code requirements. A separate, similar building also provides space for administrative functions, lifeguard break area as well as concessions. The administrative and life-guard spaces are adequately sized however the layout and use of space is slightly inefficient. In addition, there is a need to add additional lockers for staff use. Although functional, the concession space is tight and lacks sufficient storage.

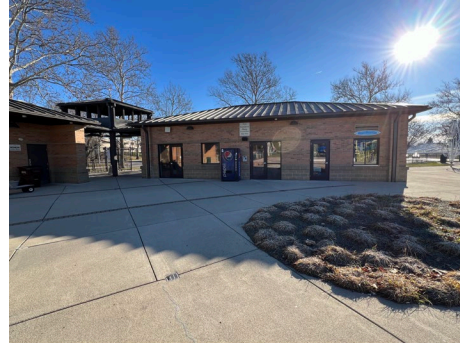
Men's/Women's View of locker Room

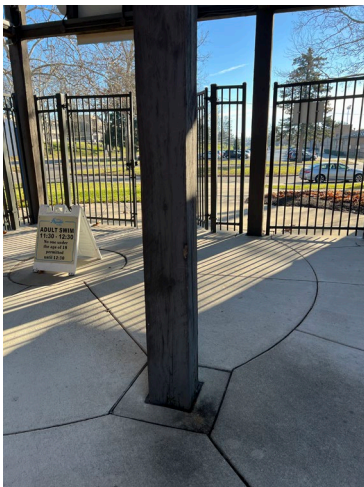
Wood Column Water Damage at Base

Primarily constructed of exposed wood, this structure is beginning to show some deterioration. One of the primary structural columns is showing significant rot that appears to be from exposure to water. While the one is worse than the other three, all four columns are in the beginning stages of some level of compromise. If not addressed within the next 3-5 years, the conditions will simply continue to get worse.

Replacing the column (or all the columns) would require a complete dismantling of the Pavilion and then reconstruction replacing existing materials. With that in mind, we recommend the entire structure be removed and replaced with a painted steel (galvanized) structure. This approach will be more in-line with the building structures which were constructed with durability and low-maintenance in mind. A new structure would have added value and could potentially be designed differently further enhancing the refresh of the overall facility.

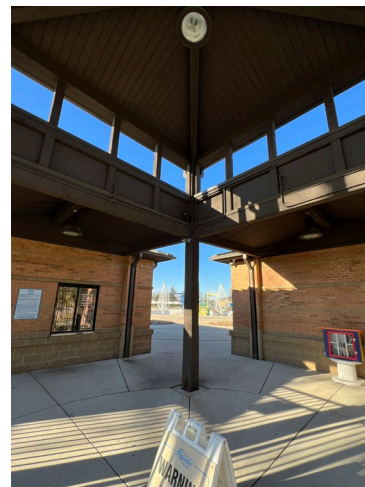
Overall View of Pavilion

The two buildings are connected with an open-air pavilion which primarily functions as the primary ingress and egress point to the pool facility. As-is, this pavilion is eye-catching and adequately signifies this is the point of which individual enter or exit the facility. The structure also provides cover during minor storm events and allows users to potentially wait out a storm as it passes.

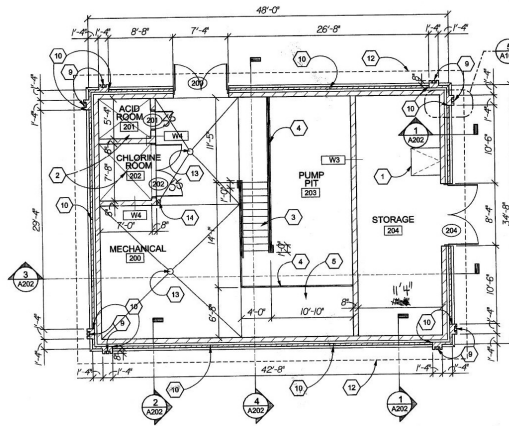
Equipment Building Plan

The existing pool mechanical building is in good condition and located on the site appropriately. Although tight, the building seems to be appropriately sized. This building is constructed similar to the bathhouse structures with load bearing masonry and a wood truss roof structure.

Although in satisfactory condition, the equipment building is maxed out as related to usable space. This could become an issue as pool equipment is changed, upgraded, or even added too.

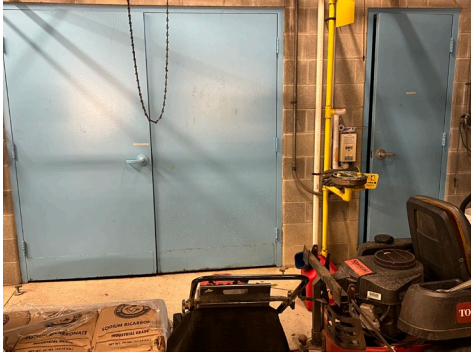
Interior Doors at Chemical Storage

Even though the building is in good shape, we do recommend replacement of all doors and associated hardware. The interior doors at the chemical room have rusted while the exterior doors are dented and showing wear and tear from 20 years of usage. In addition, the ventilation (exhaust) should be upgraded within the Acid and Chlorine Rooms.

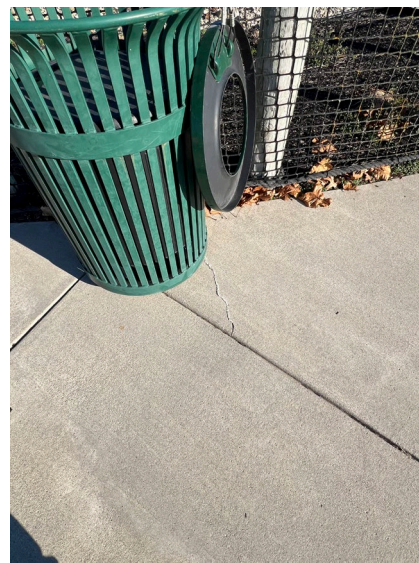
Minor Cracking in Concrete Deck

The concrete deck surrounding and connecting the pools is in excellent condition and has been well maintained. There are a few minor cracks that should be addressed with replacement, but overall condition is acceptable. The adjacent landscaping is protected with a post and rope/net feature which themes the facility. However, the rope/net requires replacement as it's condition has been significantly compromised from the constant exposure to weather over the last 20 years. Shade is provided from large umbrellas distributed throughout and around the deck as well as in the zero entry area of the pool. These shade structures have been well-maintained..

- The existing pool deck, greenspace and landscaping have been very well maintained. There are some minor cracks in the pool deck that should be addressed as well as replacement of the "rope" and some posts at the edge of the landscaping.

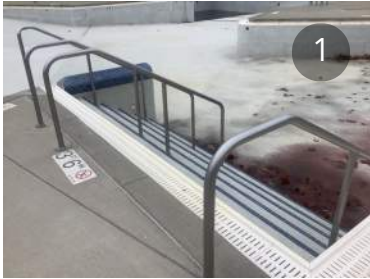
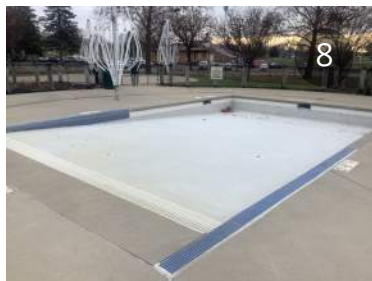
Primary ADA means of access is not present. Primary ADA access can either be a pool lift or ramp (sloped entry) with two handrails down to at least 2 feet of water depth. Secondary ADA means of access is by way of the stairs with narrow handrails, refer to pictures 2 and 3.

General means of access are by way of the zero depth area on both pools. There are one set of wide stairs at the end of the plunge area that also include a secondary ADA access with the narrow rails.

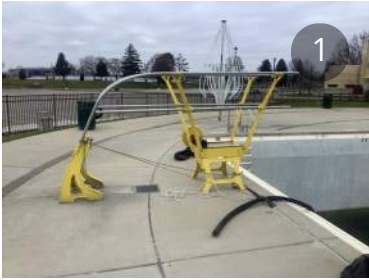
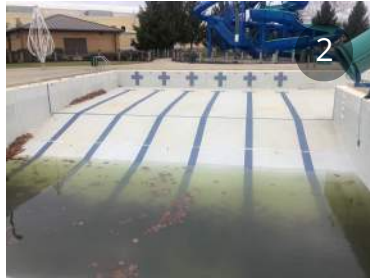
There is one 1-meter springboard. The board itself has been stored for the winter. Overall it is in good condition with the support frame being recently painted.

There are six starting platforms that are stored for the winter. According staff they are in good condition.

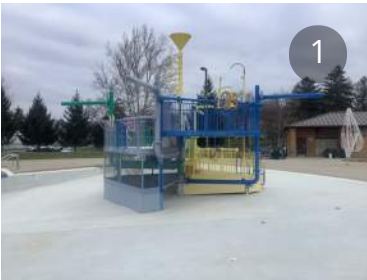
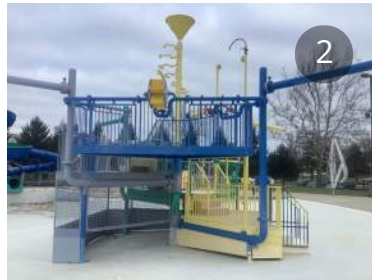
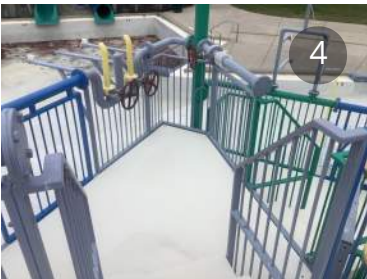
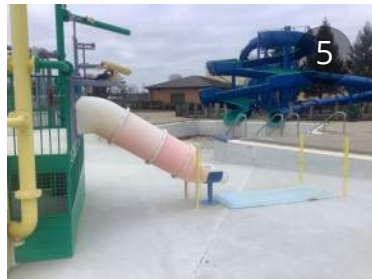
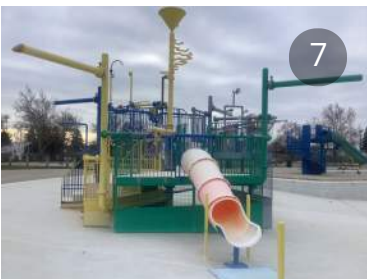
In the leisure pool there is a series of ground sprays (geysers) along the very shallow end of the zero depth gutter. There is a group of five geysers at one end and five additional sprays, equally spaced along the zero depth grating. In the wading pool there is a group of five geysers along one side of the zero depth grating.

There is an SCS Watercolors play structure in the middle of the zero depth area of the leisure pool. The play structure itself is in good condition for its age. The one slide off the structure has severely faded over the years but functional and safe to use. The slide is equipped with a landing pad and barrier at the bottom. According to staff, there has been regular annual maintenance on the structure to keep it in good condition.

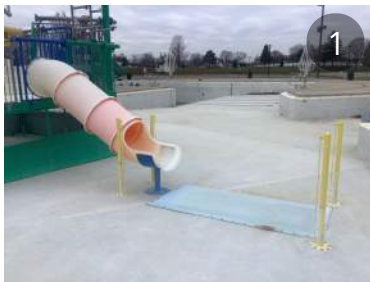
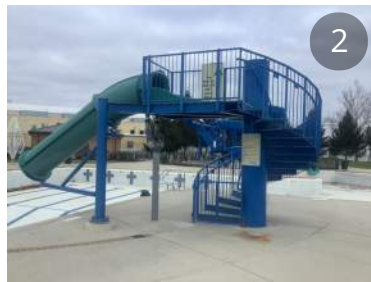
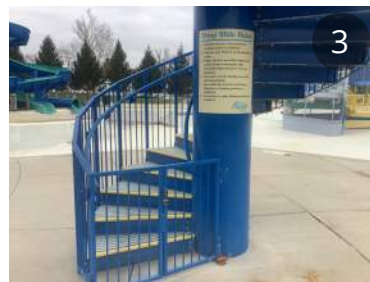
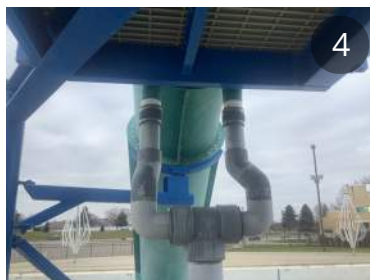
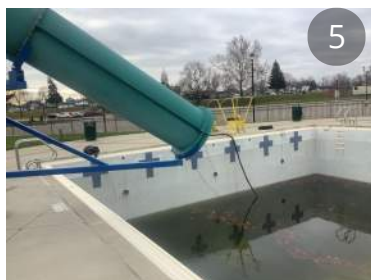
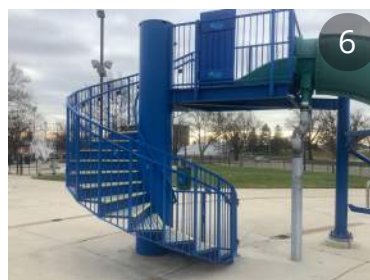
Flumes - Both flumes are fiberglass in construction and in good condition. The closed flume is 147'-6" in length and the open flume is 259'-3" long. Both flumes start at the top of the tower and terminate in the plunge pool area of the pool. Even though in reasonably good condition, the open flume slide should be re-caulked soon and there are sections that require replacement.

Barriers - There is a complete barrier around the slide tower consisting of wooden bollards with rope and netting. The barrier is showing its age and in fair condition.

Drop Slide - There is one drop slide located on the side of the lap lanes at the deep end of the pool. It has a closed flume that terminates above the water and starts at the top of the tower. The tower is constructed of painted galvanized steel with circular stairs, railings, handrails and locking gate at the bottom. Overall the slide flume and tower are in good condition, however should be re-coated and re-caulked. There is no barrier around the tower to protect patrons from bumping their heads on the stairs that are 7'-0" or less above the deck. WTI recommends a barrier around the slide towers with low hanging structure.

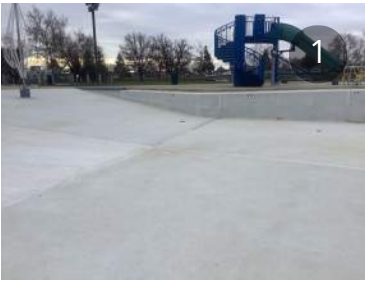
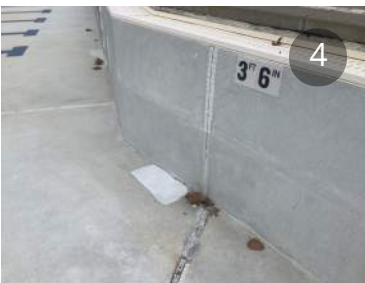
Both pools are constructed of concrete and appear in good condition with no visible cracks or spalling.

The Wading pool is constructed as one continuous pour for the floor while the Leisure pool is constructed of multiple pours. This leave several expansion\control joints throughout the pool. The joints themselves are in very poor condition with much of the caulk missing or severely cracked. The tile along each of the joints is also in poor condition.

The Leisure pool has five (5) underwater pool lights that are in fair to good condition however are not functional. It is not known if they are all working as the pool was drained at the time. The Wading pool does not have any in pool lighting.

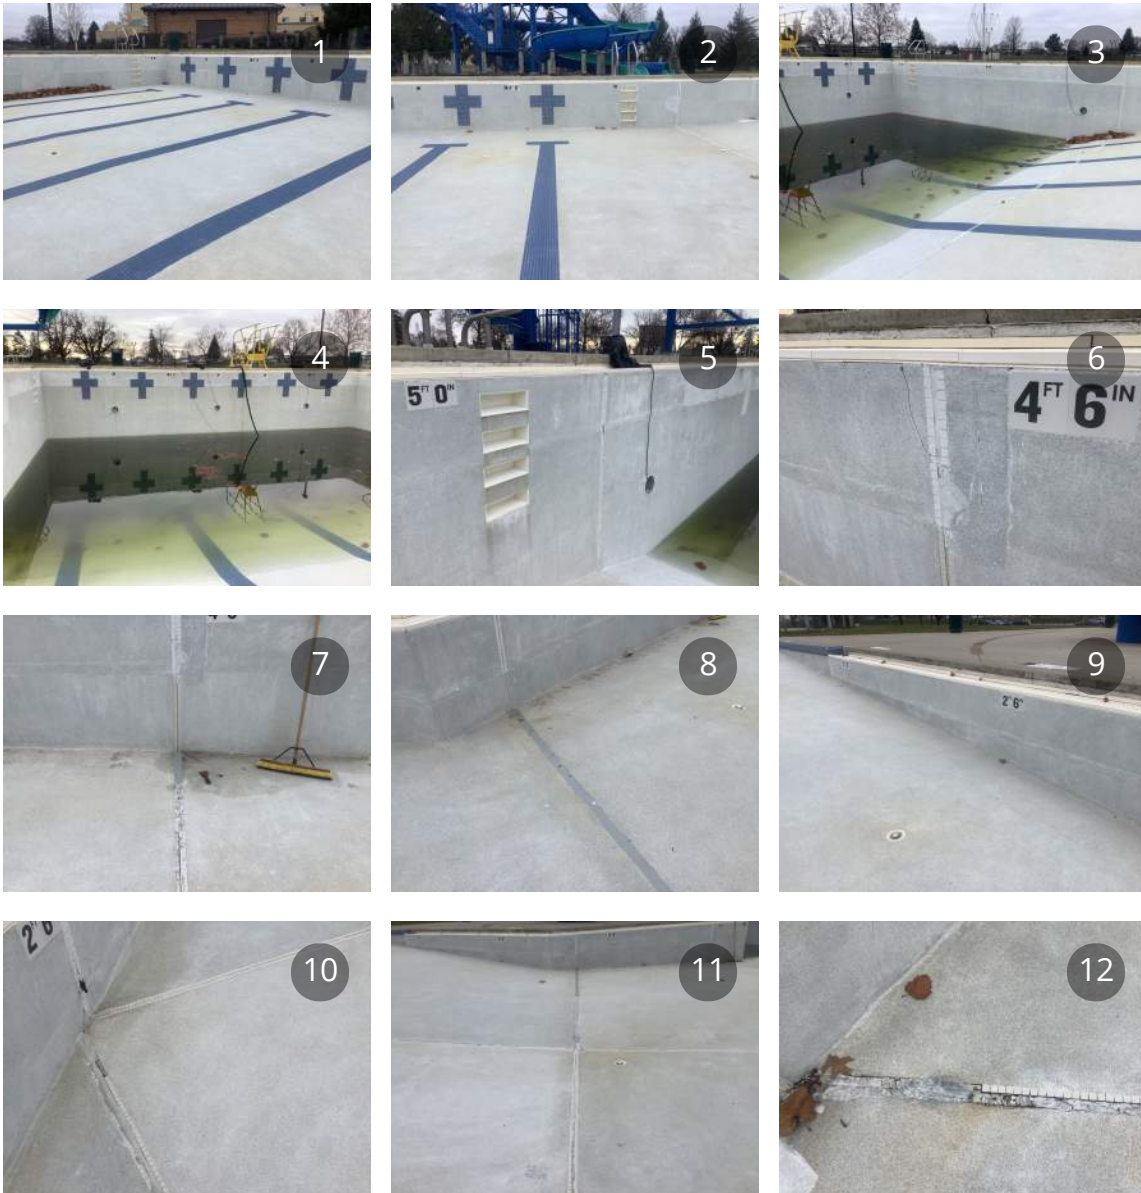
Depth Markings

The primary pool finish in both pools is quartz aggregate finish. The quartz aggregate is original to the pools and is in fair condition. Over the years there are several locations that have been patched\repaired and this will continue with age if its not replaced.

The secondary finish is ceramic tile for the lane lines, end-wall targets, common walls and water line at the zero depth area. Several areas of tile have to be replaced each year do to freeze thaw conditions. Remaining tile that has not been replaced is in poor condition and has little to no grout left between the tiles.

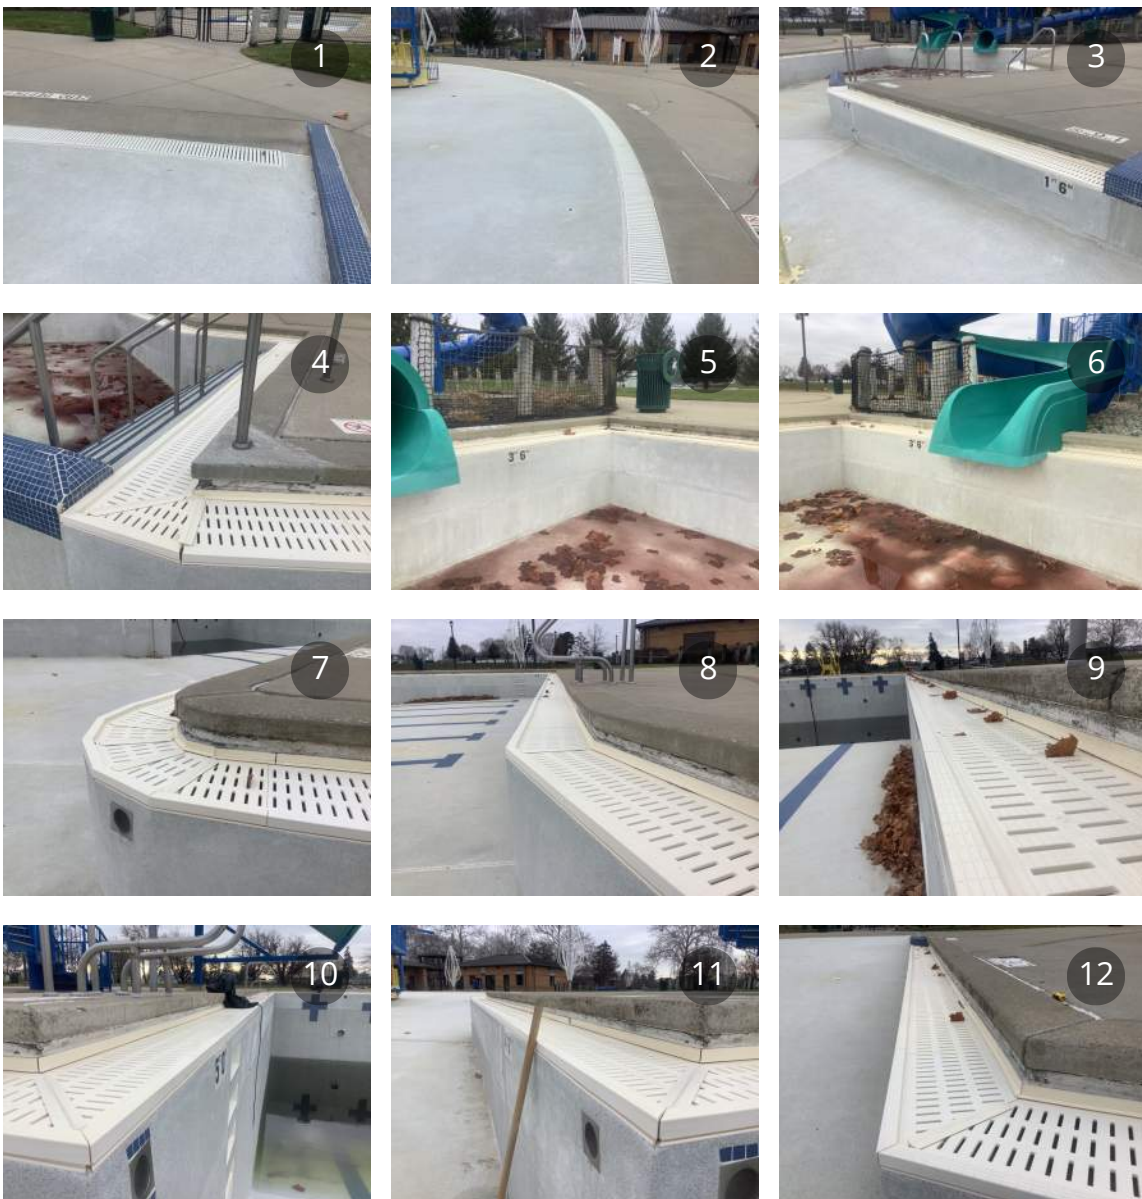
Perimeter skimming is handled by way of a concrete gutter with a PVC Swimout Overflow Grate System. The grating is in fair condition for its age and use. Staff noted that it is not possible to get replacement sections as this product is no longer manufactured. A small allotment of replacement sections have been purchased and is not on hand, however replacement of the entire grating system is a very high priority. At the zero depth entry there is a flat 12' grate that is in fair condition.

The Children's pool utilizes two skimmers and a zero depth entry grate for skimming. The skimmers and zero depth grating are in good condition.

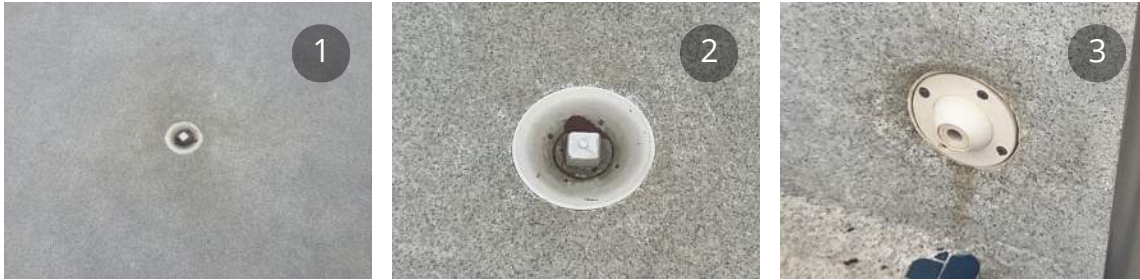
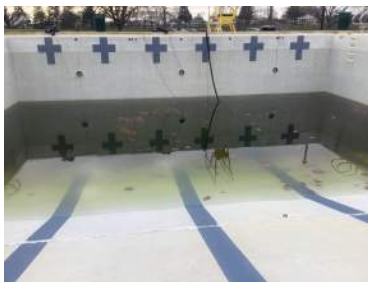
Both pools utilize floor inlets for filtered water return. The Leisure pool has 38 floor inlets and the Children's pool has 5. All the floor inlets have been capped for the winter and appear to be in good condition. The Leisure pool also has two wall inlets located on either side of the stairs at the slide plunge area.

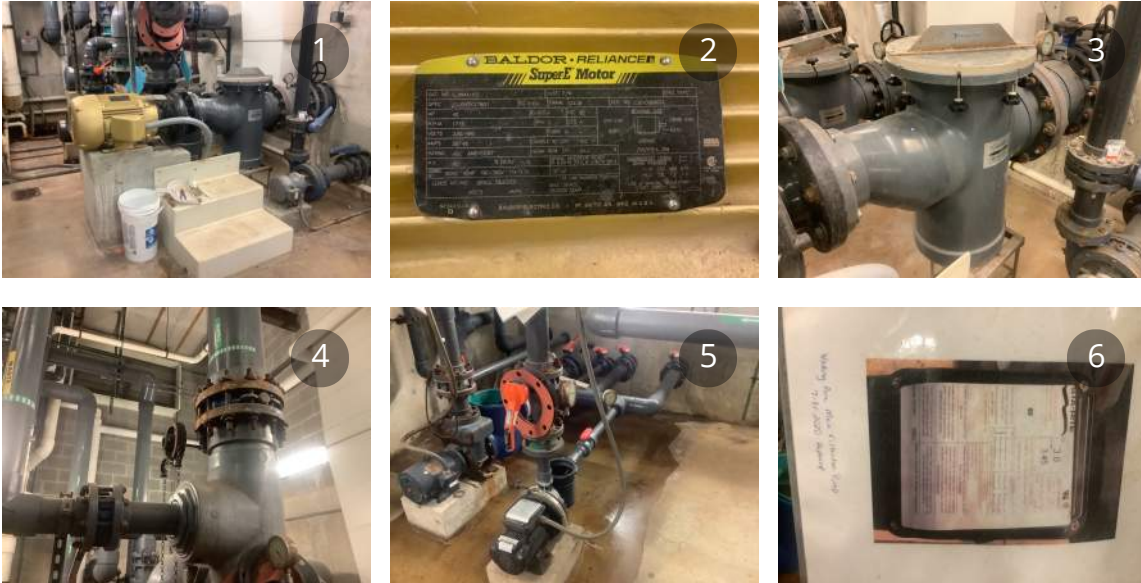
The filtration pump is an Aurora model 340-ES, size is 6x6x11 and has a 40 HP Baldor motor. The pump and motor are in very good condition and have been well maintained over the years. This pump did receive a variable frequency drive several years back which has helped extend its life.

The pump is equipped with a PVC strainer on suction side of the pump with stainless steel strainer basket and a spare basket.

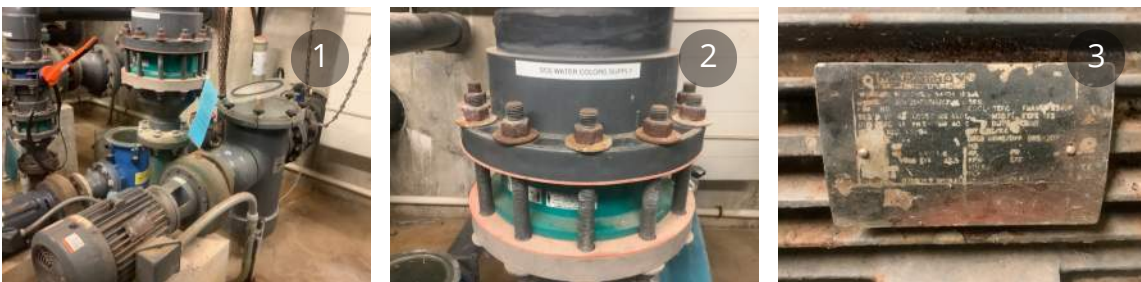
The Watercolors activity pump is an Aurora model 340-ES, size is 6x6x9 and has a 20 HP motor. The pump and motor are in fair condition and will be in the need of maintenance over the next few years. This pump does not have a variable frequency drive.

The pump is equipped with a PVC strainer on suction side of the pump with stainless steel strainer basket and a spare basket.

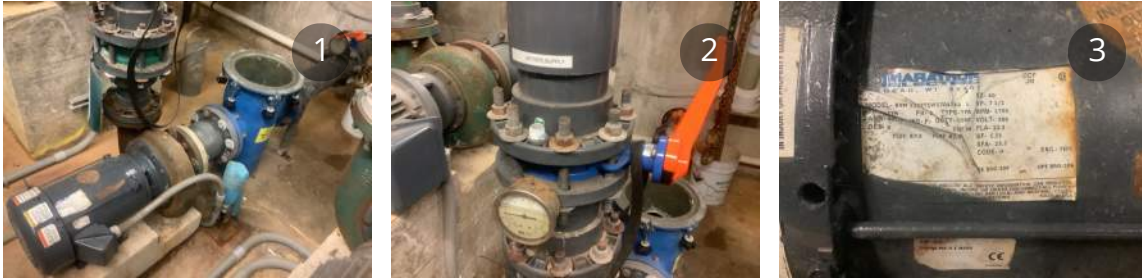
The geyser supply pump is an Aurora model 340-ES, size is 4x5x9B and has a 10 HP motor. The pump and motor are in good condition and have been well maintained over the years. This pump does not have a variable frequency drive.

The pump is equipped with a fiberglass strainer on suction side of the pump with stainless steel strainer basket and a spare basket.

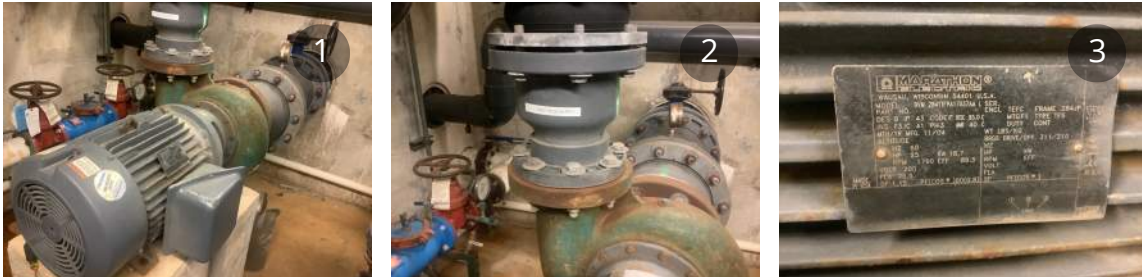
The body slide pump supplies water to both body slides and is an Aurora model 340-ES, size is 6x6x11 and has a 25 HP motor. The pump and motor are in good condition and have been well maintained over the years. This pump does not have a variable frequency drive.

The pump does not have any type of strainer on the suction side.

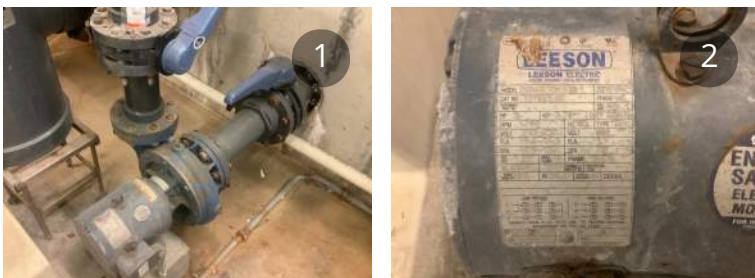
The drop slide pump is an Aurora model 340-ES, size is 4x5x9A and has a 7.5 HP motor. The pump and motor are in good condition and have been well maintained over the years. This pump does not have a variable frequency drive.

The pump does not have any type of strainer on the suction side.

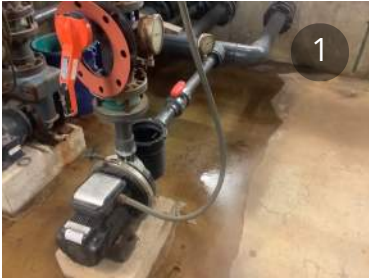
The filtration pump is a Sta-Rite, Dura-Glas II series, #P4R6H3 and has a 3 HP motor. The pump and motor are in good condition and have been well maintained over the years. This pump does not have a variable frequency drive.

The pump is equipped with an integral strainer bolted directly to the suction side of the pump with a plastic strainer basket and a spare basket.

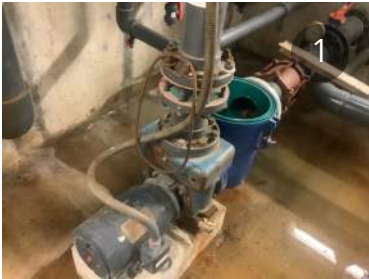
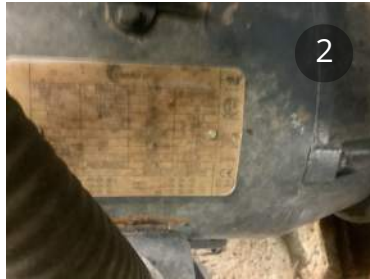
CHILDREN'S POOL GEYSER PUMP

The geyser pump is a Sta-Rite, CCSP series, #CCSPHK3 and has a 7.5 HP motor. The pump and motor are in good condition and have been well maintained over the years. This pump does not have a variable frequency drive.

The pump is equipped with an integral cast iron strainer bolted directly to the suction side of the pump with a stainless steel strainer basket and a spare basket.

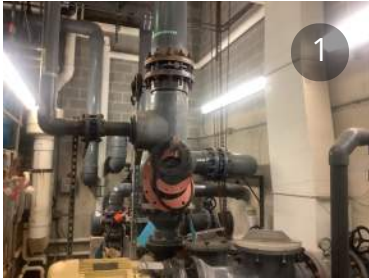
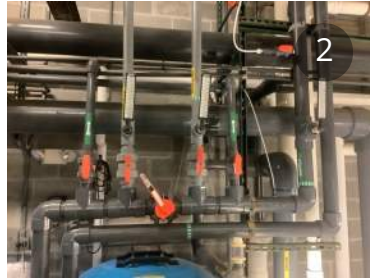
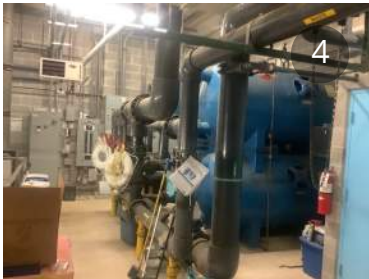
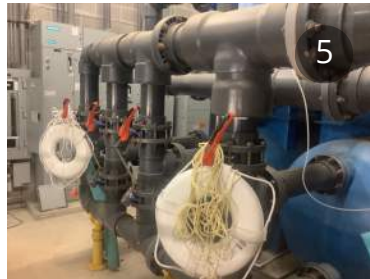
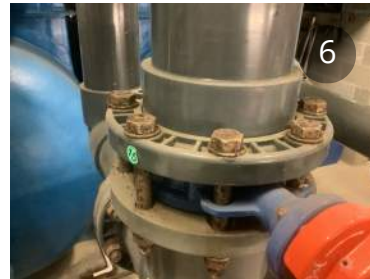
OBSERVABLE PIPING

All observable piping was in the mechanical room and made of sch 40, sch 80 and CPVC. There was a small amount of sch 40 for the backwash hub and trap. The majority of the piping is all sch 80 pvc for all suction and pressure lines. There is also about 150 feet of CPVC for the connections to and from the pool heaters. Most piping looks to be in good condition, however the piping over the main pump should be replaced.

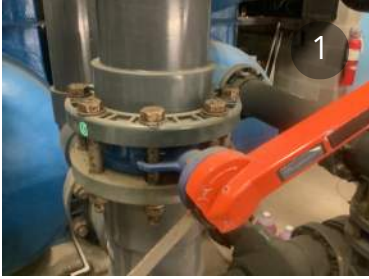
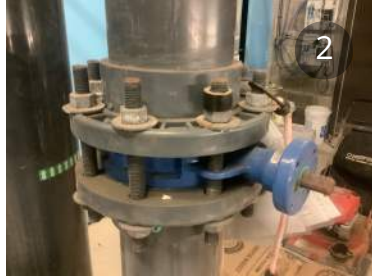
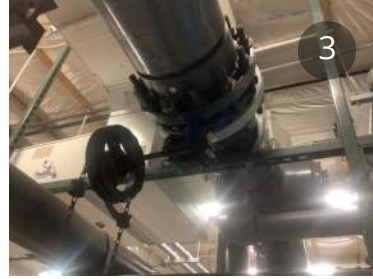
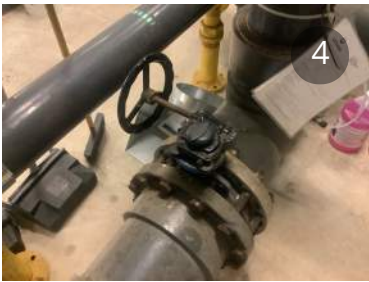
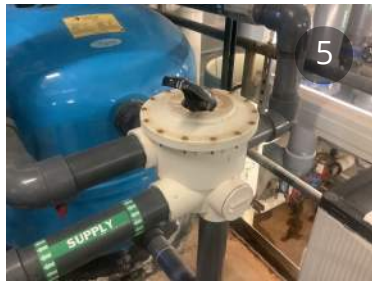
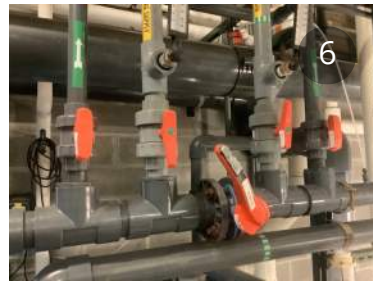
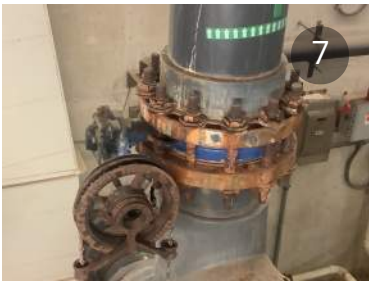
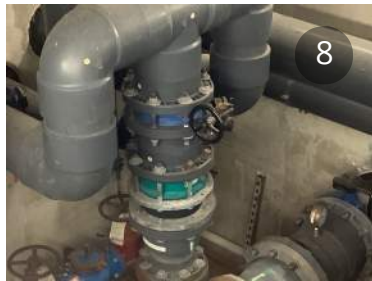
OBSERVATION VALVES

There are 31 observable butterfly valves, ranging in size from 4" to 10" with a combination of lever and gear handles. The valves are in fair condition with some having excess corrosion.

There are 10 observable ball valves that are all in good condition.

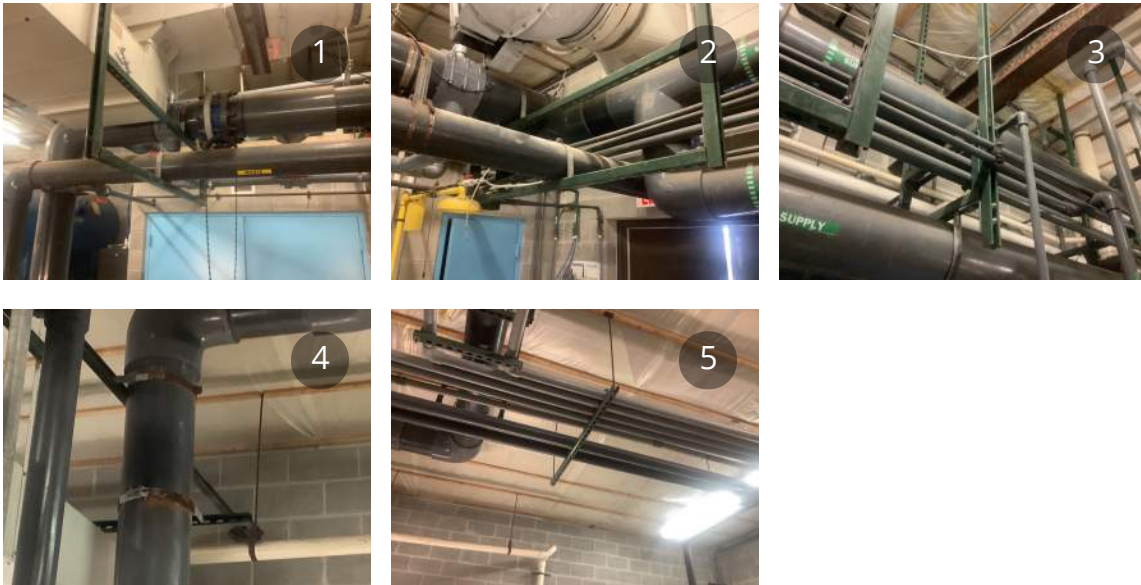
The pipe supports and hangers are made up of unistrut with threaded rod and hanger clamps. All appear to be in good condition.

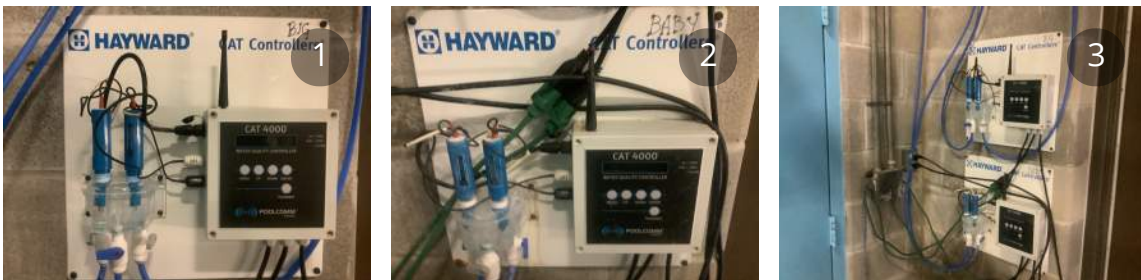
The chemical controllers are both CAT4000 controllers that were installed approximately 5 years ago. They are a fairly advanced controller that appear to be in fair condition and should be replaced within the next 2-3 years.

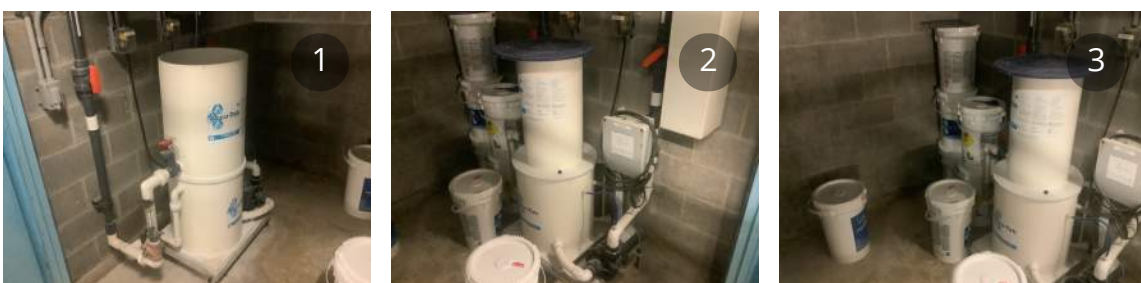
Both pools utilize Calcium Hypochlorite for disinfection. The Leisure pool has a PPG model 3140 chlorinator and the Children's pool has a model 3070. Both units appear to be working, however they leak and are in poor condition and should be replaced. The units are housed in their own ventilated room.

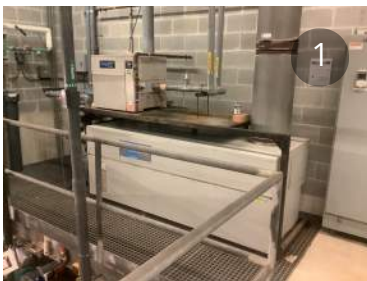
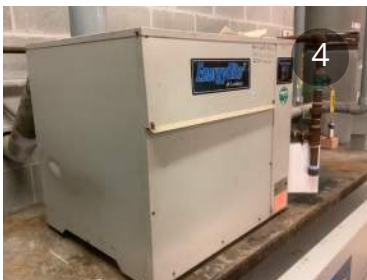
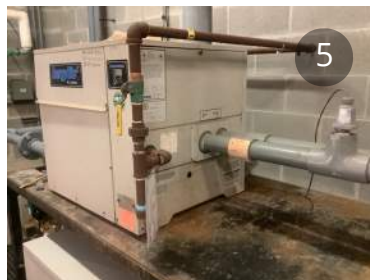
POOL HEATING

Heating for both pools is by way of natural gas pool heaters. The Leisure pool has a Lochinvar CPN2070, 2,070,000 BTU/Hour pool heater and the Children's pool has a Lochinvar ERN201, 200,000 BTU/Hour pool heater. The Leisure pool heater has been recently replaced (2023) and is in very good condition. The Children's pool heater is the original heater and is in fair condition.
